## PROPERTY CONDITION REPORT

1006 SE Grand Ave., Portland, OR,

9/22/2008 at 6:41 PM

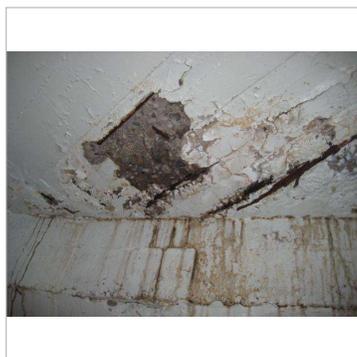
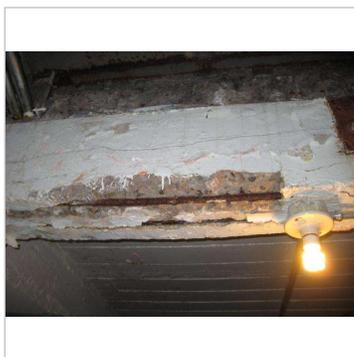
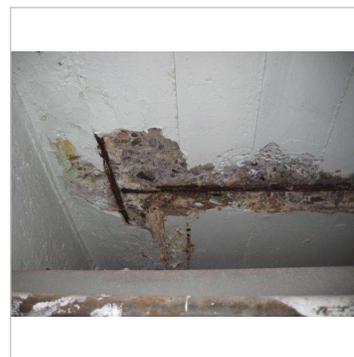
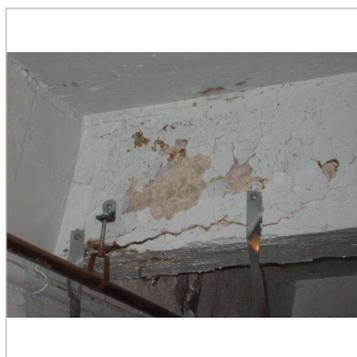
- 1.1.4 There are areas of interior space below grade, which will be susceptible to moisture intrusion. There is evidence of intrusion at this time. This is obviously a condition of the building itself and will remain an ongoing maintenance issue. These problems may worsen with time and ultimately require more drastic measures than simply coping with the water as is the current method. However, you may also wish to have a second opinion.

There is a section of basement area under the sidewalk that is subject to moisture intrusion and the result of water cascading down the walls and through the concrete is evident on the walls and ceiling. In the ceiling areas there is concrete southing off and cracking in some places. The steel re enforcement within the concrete is exposed and is quite deteriorated by corrosion. As this is an ongoing process, the steel re enforcement yet encapsulated by the concrete may be deteriorating as well and the structural integrity is likely suffering. There is no real way to determine the extent of the damage without "coring" the concrete and that would also weaken it.

The final analysis here is this; This condition has likely existed since the structure was built and it is currently structurally sound 101 years later. However, at some point in the future, the integrity of the reinforced concrete in this area will be compromised and will require repair. You may wish to engage the services of a structural engineer to advise you as to this condition further.

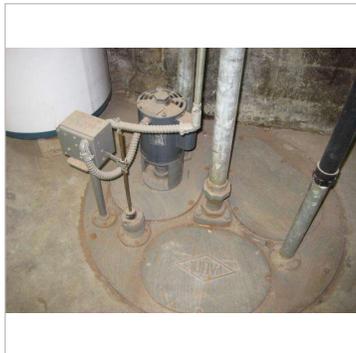
- 1.1.11 The sump pump in the basement does not have ground fault protection, and should be upgraded as soon as possible to have this essential safety feature.

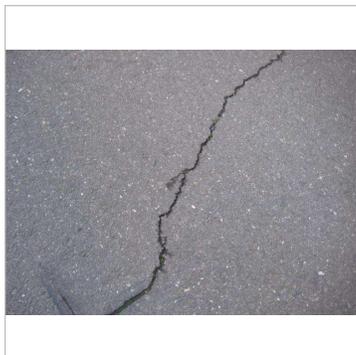
- 1.1.13 The parking surfaces have been evaluated and found to be in serviceable condition. However, the parking area (10,000sq/ft.) is due for seal service. This will insure it's continued service for some time. Otherwise is will begin to break down. Even now, there is some loosening of the surface gravel and cracking of the material.

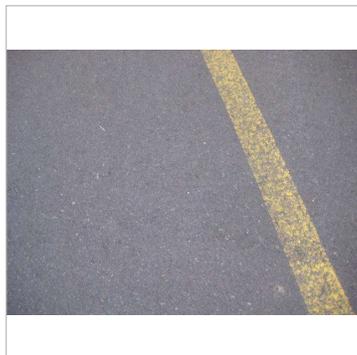
- 1.1.14 The parking stripes are worn and not as distinct as they could be, and should be scheduled for service. The stripes should be painted when the surface is sealed.

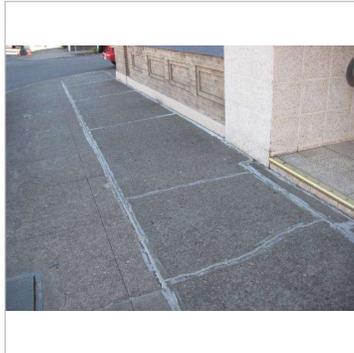
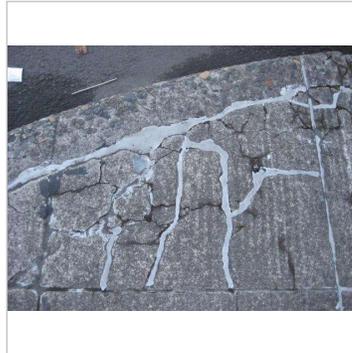
1.1.22 The walkways are variously damaged and should be repaired or replaced. There are cracks in the sidewalk across the front of the building on the West side. The sealant in these cracks is due to be serviced. This is the likely source of much of the water intrusion in the basement area. This will prove to be an ongoing maintenance issue with the property.

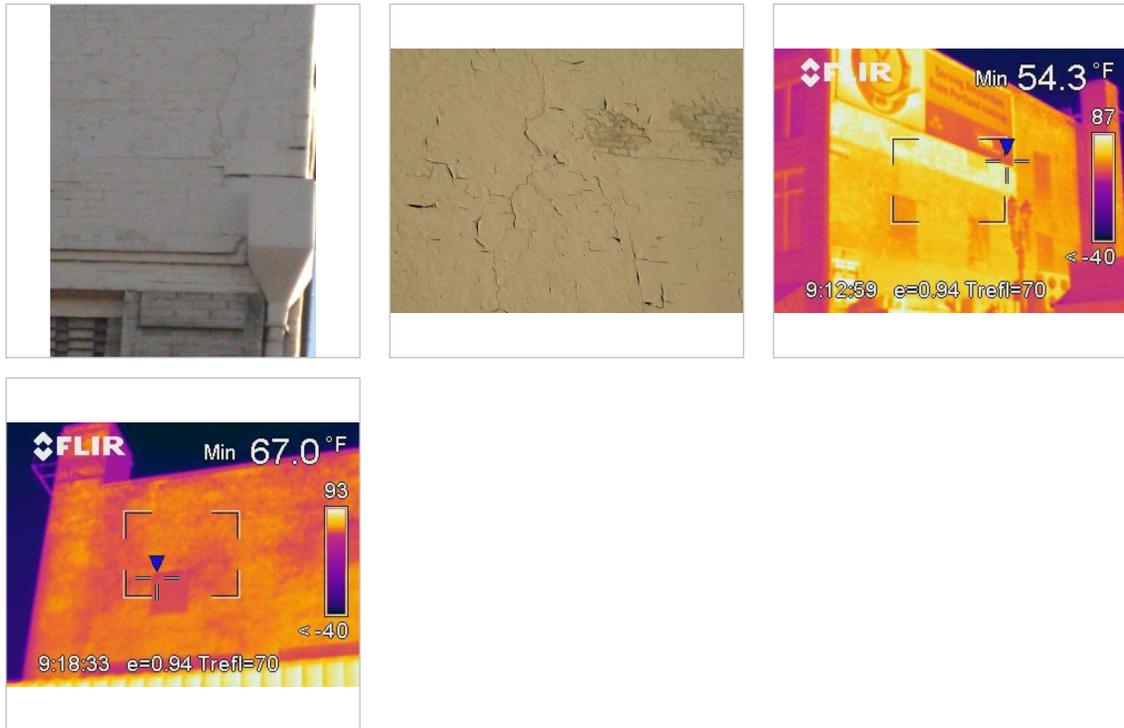
- 1.1.31 The building walls consist of bricks that are in generally acceptable condition. The surface bricks at the front are newer and in good condition. The upper portion of the front and the rest of the building consists of brickwork that is covered in some areas with plaster and painted all over. There are several layers of paint and many areas where the paint is blistering off. Many areas of the surface had blistering paint that was subsequently painted over without proper surface preoperation. The building exterior cladding surface is near the pint where it will require repainting. If the paint/seal surface is not maintained, it will hasten the deterioration of the brickwork and mortar holding it together. There are some areas that require some work now but they are actually very few.

Thermal imaging analysis shows that where the paint surfaces are deteriorated, there is a different thermal pattern. This too is hastening the deterioration of the painted surface protecting the old underlying brickwork.

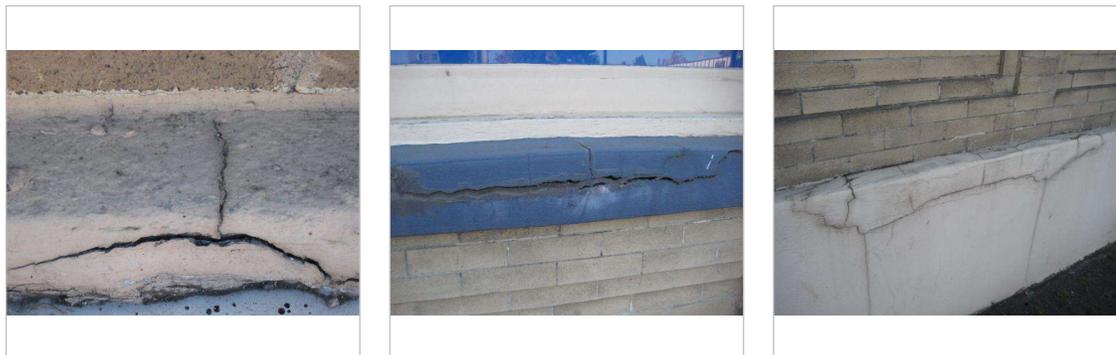
- 1.1.32 Base areas are deteriorated. There are concrete "trim" sections at the base of the building that are deteriorated. They have been "caulked" for repair but these repairs are inadequate and coming apart. The damaged areas should be cut out and re-formed.

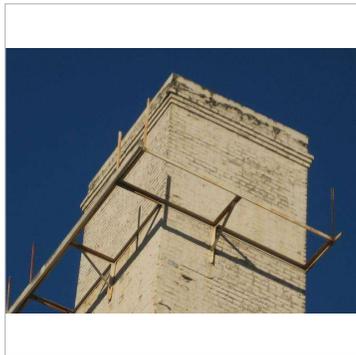
- 1.1.39 The chimney balcony or walkway needs to be serviced for the reasons indicated. The standing surface and guardrail are completely gone. The remaining structure should be rebuilt or removed.

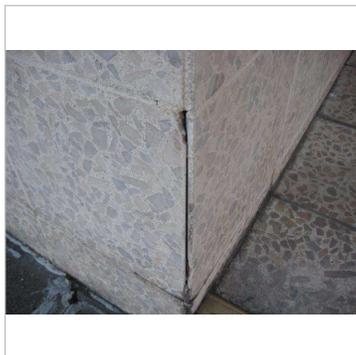
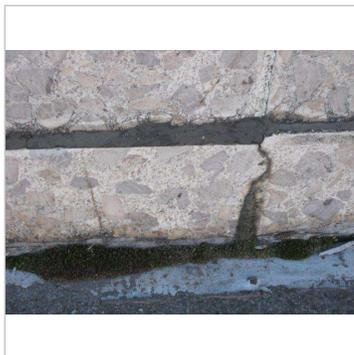
- 1.1.41 Entry components need service. There are some deteriorated grout areas at the main West side entry. Along the base at the sidewalk and up the edge (this is not extensive but does require service or it will worsen and tile can come loose).

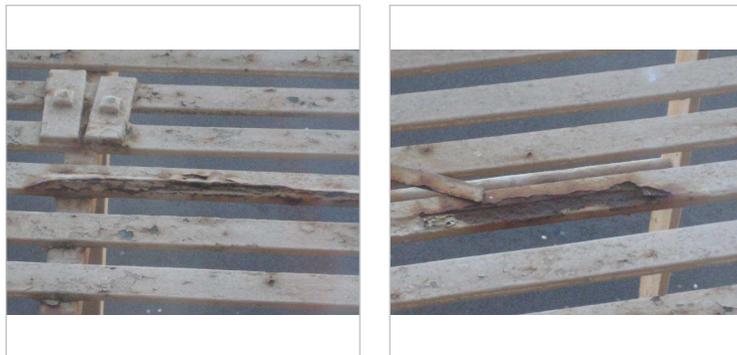
- 1.1.42 The structure needs to be serviced for the reasons indicated; The paint surface is compromised and the metal is rusting in some areas to the extent that the structural integrity may become deficient soon if not corrected. The fire escape should be cleaned and repainted after welding any damaged areas.

The access window on the 2nd floor needs service.

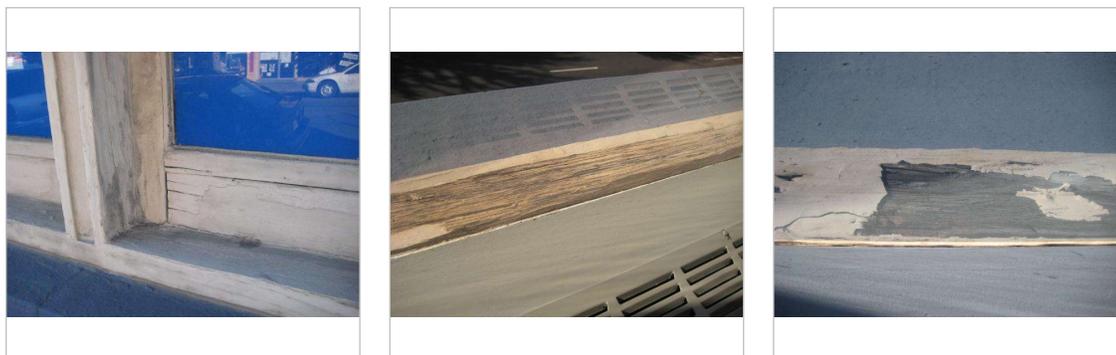
- 1.1.43 The wood trim, around the windows is weathered and has dry rot in several areas. The worst offenders are the center windows on the West side of the building. Some of the wood will need to be replaced and most of it, like the building itself is due for paint service.

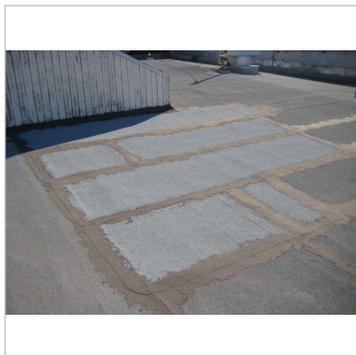
- 1.1.48 The roof is layered, which is never sensibly recommended because it reduces the design life of the new roof. This has been done in a localized "problem" area. This is at best a temporary repair, expect this area to be an ongoing maintenance issue until the entire roof surface is replaced.

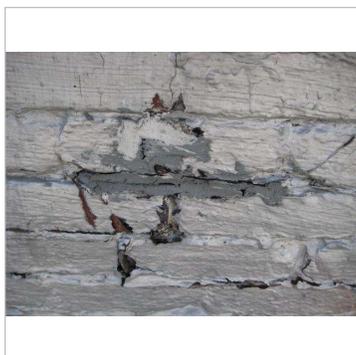
- 1.1.51 The parapet walls are in overall acceptable condition. They do need some maintenance. There is some damage to the seal surface on the interior. This will be ongoing maintenance and is typical.

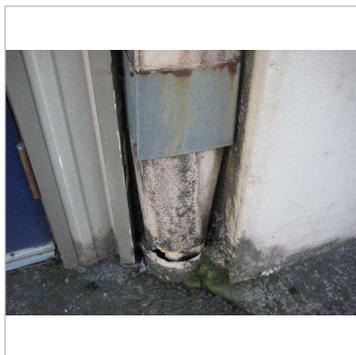
- 1.1.52 The scuppers roof drains and the drainage channels are in acceptable condition. However, without water it is difficult to judge whether they are correctly pitched to direct water into the drains, but they should function as they were intended. There is a downspout that needs to be serviced. It has been patched with sheet metal but the lower section is corroded away and will allow drainage onto the adjacent sidewalk.

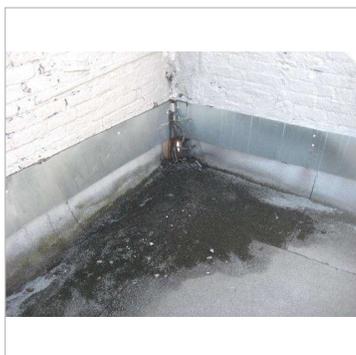
- 1.1.53 The drains and scuppers need to be cleaned and serviced to drain properly.

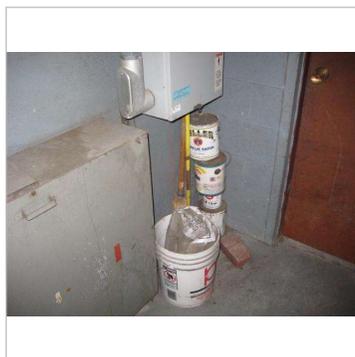
- 1.1.70 inappropriate storage, hazard. There is paint being stored in the electrical utility room, under the Verizen service panel.

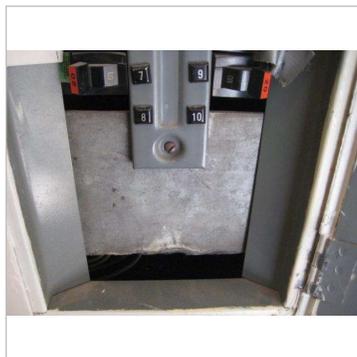
- 1.1.74 We have evaluated the sub panels in accordance with ASTM standards, and found them to be in generally acceptable condition. However some have some hazard deficiencies that call for service in a timely manner.

subpanel in basement phone room missing plate

subpanel on 1st floor open breaker gaps

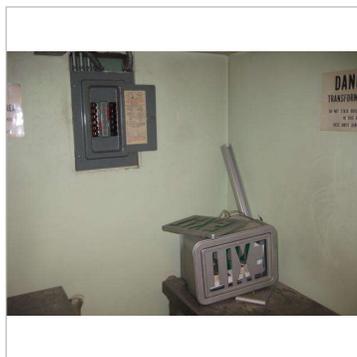
- 1.1.76 The sub-panel in the 3rd floor mezzanine storage does not have thirty-six inches of clear space in front of it, to facilitate service or an emergency disconnect, and should be made accessible.

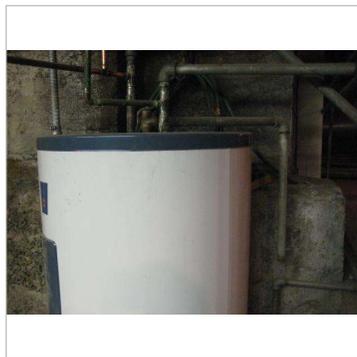
- 1.1.85 Hot water is provided by multiple water heaters, consisting of 3, 5-8 year old, 65 gallon, electrically-fueled water heaters, and one 15 year old water heater located in the basement. They area all in acceptable condition although the connections on one heater are corroded and another is at the end of it's expected service life.

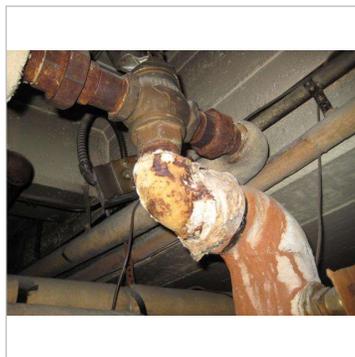
- 1.1.94 The pipes and valves were evaluated and judged to be functional. there is an elbow that is deteriorating and should be replaced soon.

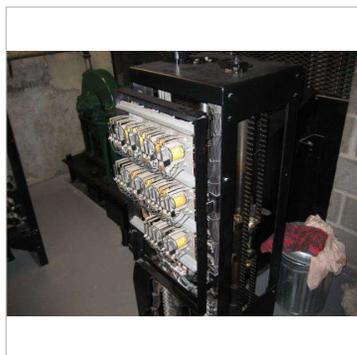
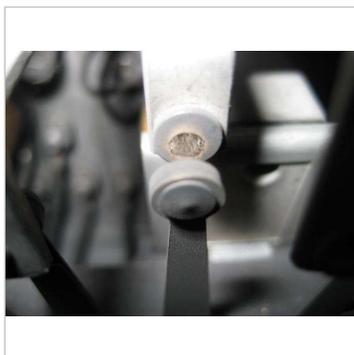
The current inspection sheet was not posted in the elevator mechanical room at the time of the inspection. This is mandated and should be corrected. The maintenance record for the elevator were not on site at the time of the inspection so they could not be evaluated. It is highly recommended that you obtain these maintenance records.

This is an older unit that appears to have been maintained, but service will be an ongoing situation. The control system is an older unit consisting of electro-mechanical switches. Some of the contacts on these switches are showing signs of wear and will need to be serviced soon.

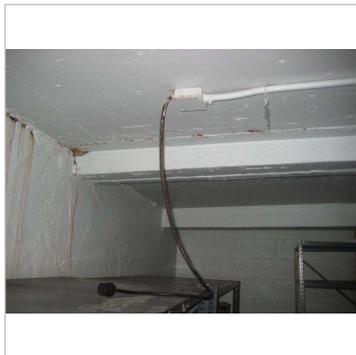
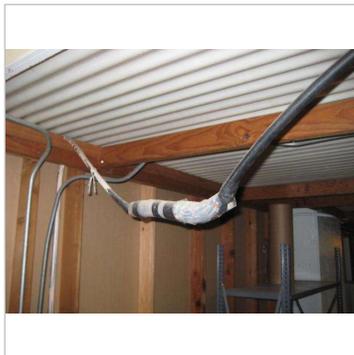
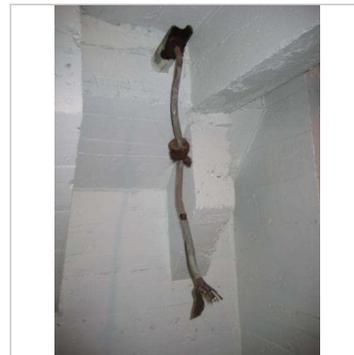
- 1.2.1 Branch circuit wiring sub standard in the basement area. Temporary wiring to junction boxes, extension cords coupled & used for other than temporary service and exposed decommissioned circuits.

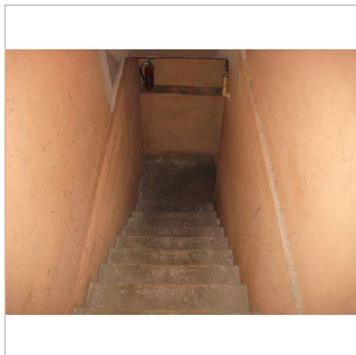
- 1.2.4 handrail needs to be installed to sub basement

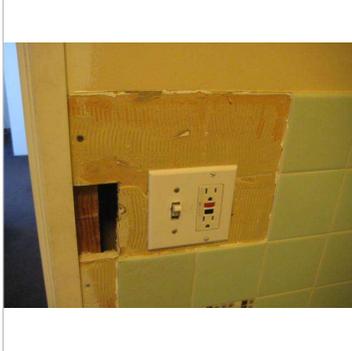
- 1.4.17 The walls and ceiling are not in acceptable condition. There are missing tiles on the wall adjacent the door.

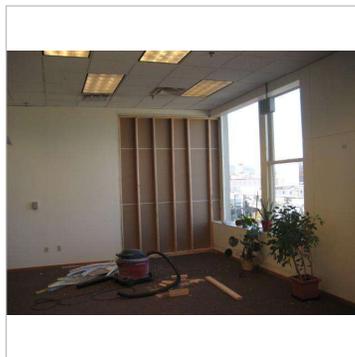
- 1.5.4 The office appears to have been remodeled or part of an addition. This is a work in progress and is not yet complete.

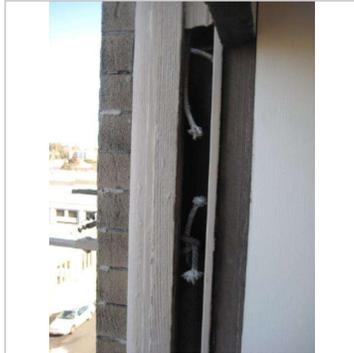
- 1.5.6 Egress window to fire escape sash cord cut must be repaired. The counter weight is essential for the safe, reliable operation of the window for egress purposes.

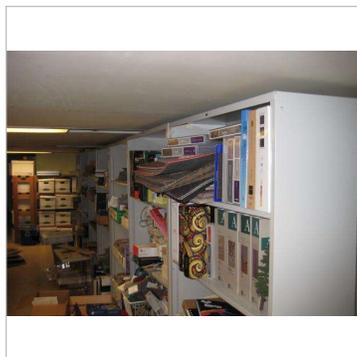
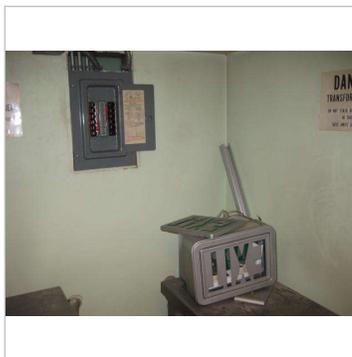
- 1.6.4 We evaluated the storage rooms using a representative sampling technique and determined that they need service, as follows: the mezzanine storage room has storage shelves that go to the ceiling and block the spray pattern of the required fire sprinkler heads.

There is also storage materials interfering with the required 36 inch clearance space in front of an electrical panel improperly on top of a transformer box.
