Shipshape Property

PROPERTY CONDITION REPORT

SE Somewhere, Portland, OR,

7/16/2007 at 8:30 AM to 7/25/2007 at 5:30 PM

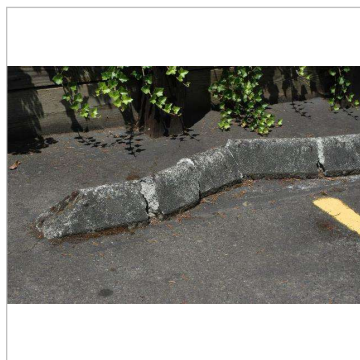
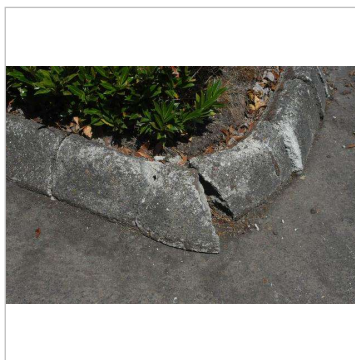
- 1.1.31 The parking stripes are worn and not as distinct as they could be, and should be scheduled for service. This is primarily in the lower rear lot. Ther rest of the striping is fine.
- 1.1.32 Curb bumpers broken or missing.

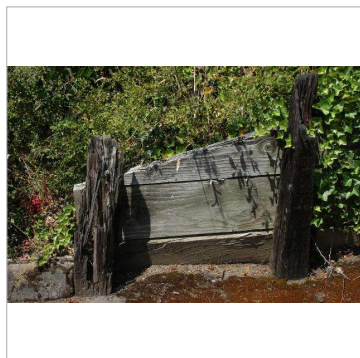
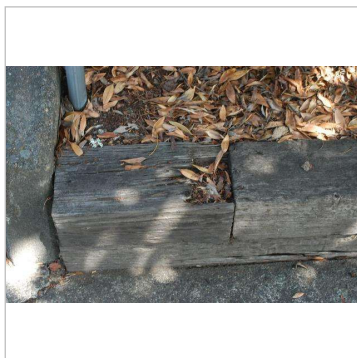
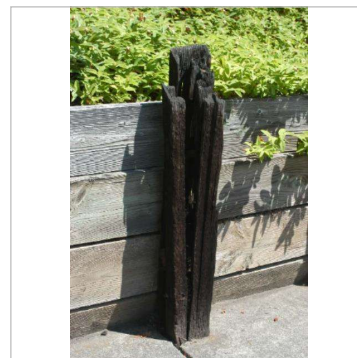
1.1.40 Wooden Yard walls show signs of advanced dry rot and deterioration. Primarily at the rear of the structure.

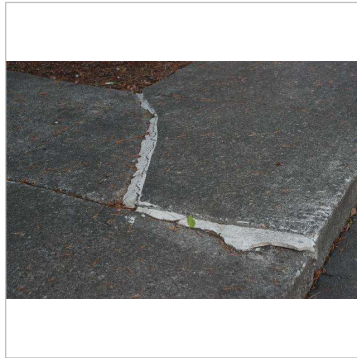
- 1.1.43 There are offsets in the walkways that could prove to be trip-hazards, which should be serviced.

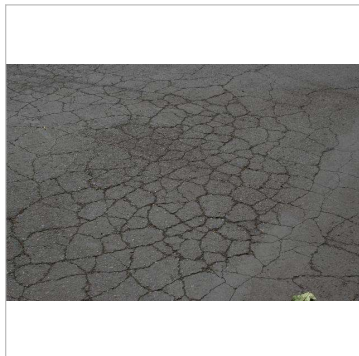
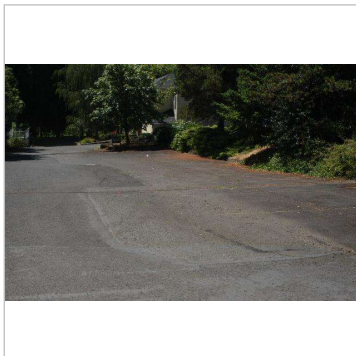
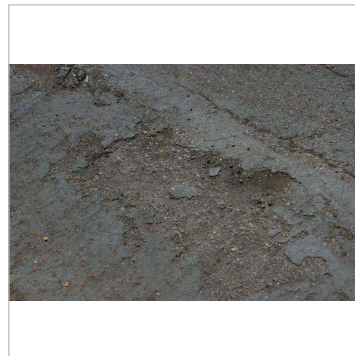
- 1.1.47 There are significant cracks or offsets in the driveway, which could prove to be trip-hazards that you may wish to have repaired. The area to the west side and lower rear were not resurfaced when the rest of the parking area was and are past due for resurfacing.

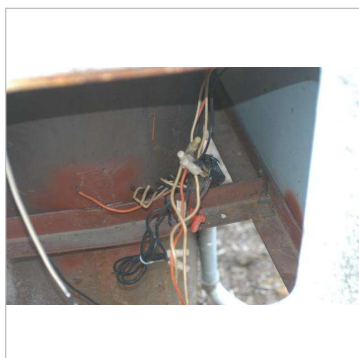
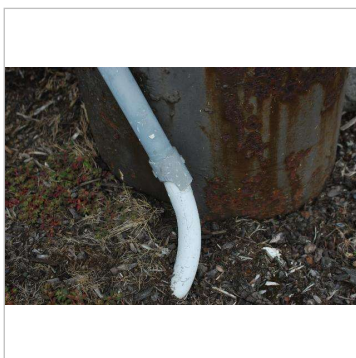
- 1.1.48 Structure in serviceable condition. There is non standard/mixture of types of conduit servicing the Main Sign. There is also substandard wiring exposed beneath the sign with open or exposed wiring.

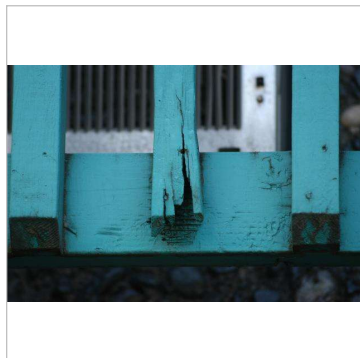
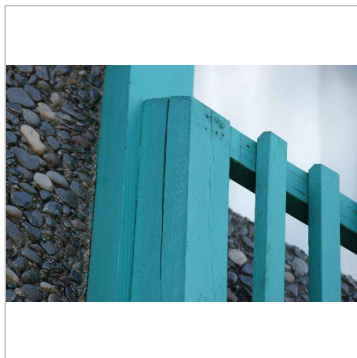
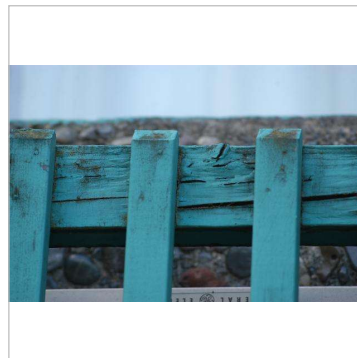
- 1.1.55 The wooden trim on the outside of the building is showing signs of weathering and dry rot.

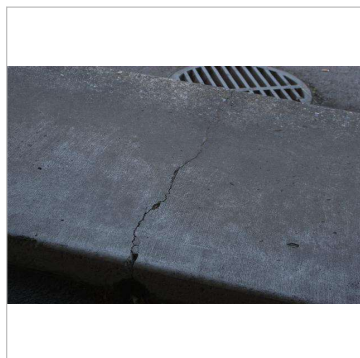
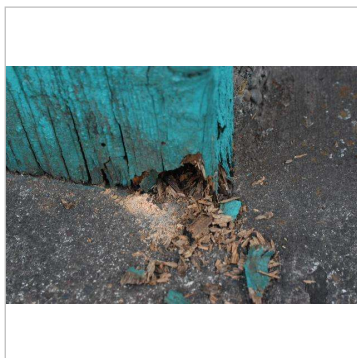
- 1.1.59 Entry components need service. The entry island concrete is cracked. There is untreated lumber in contact with the concrete that shows dryrot and WDO (wood destroying organism) damage.

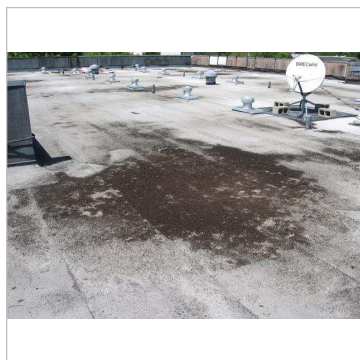
- 1.1.68 The roof is in acceptable condition, but this is not a guarantee against leaks. For a guarantee, you would need to have a roofing company perform a water-test and issue a roof certification. There are some areas of standing water and debris is building up there.

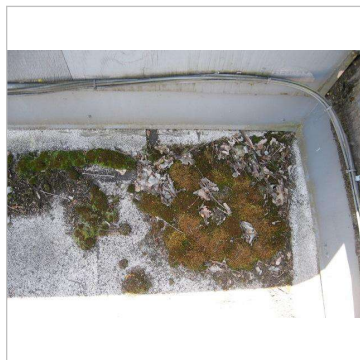
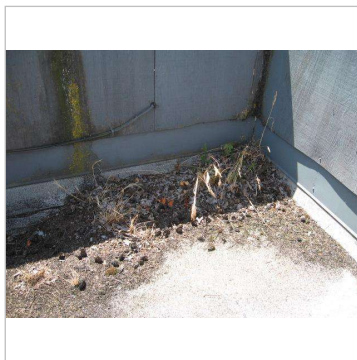
- 1.1.69 Fungus growth on roofs is a typical problem. It deteriorates the roof and shortens the service life. It is recommended that every roof be cleaned of completely each year to maintain it and keep the roof serviceable for its intended service life (15 years for a flat roof).

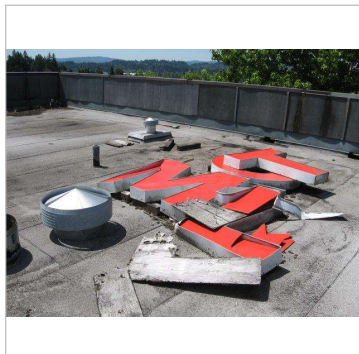
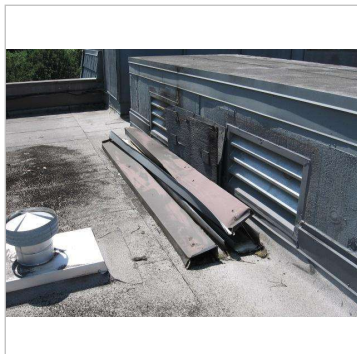
1.1.70 Debris on roof

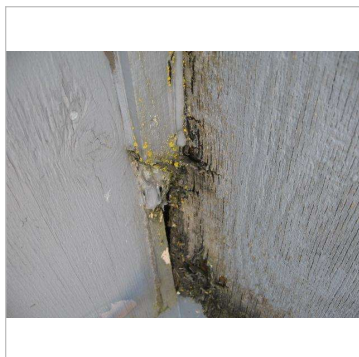
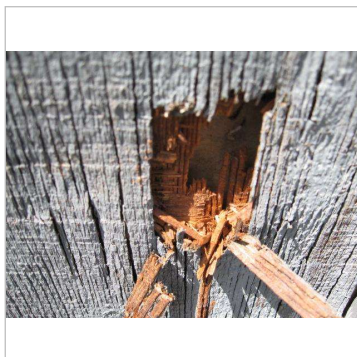
1.1.72 The parapet walls are in acceptable condition on the metal caps. They could use some sealant service as they will every 2-3 years. The parapet walls are covered with wooden sheathing and it is in bad condition showing early and advanced stages of dryrot. Most of this plywood should be replaced and kept painted.

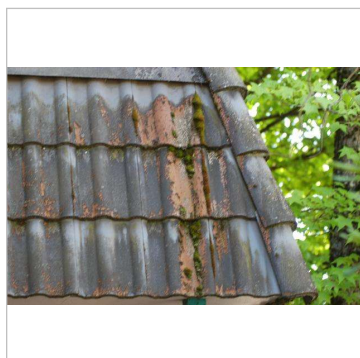
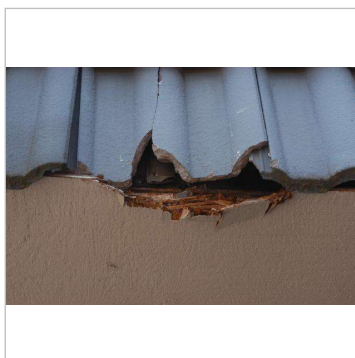
- 1.1.78 The roof is in acceptable condition, but this is not a guarantee against leaks. For a guarantee, you would need to have a roofing company perform a water-test and issue a roof certification. The tile sections of roofing are across the front and are actually more of a facade for appearances than an actual roofing. There are several damaged tiles and moss growth throughout that needs service.

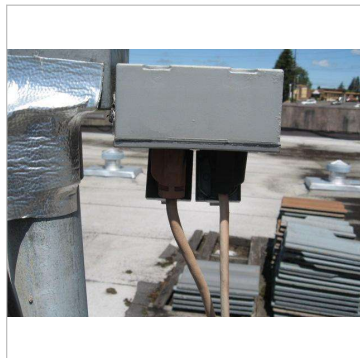
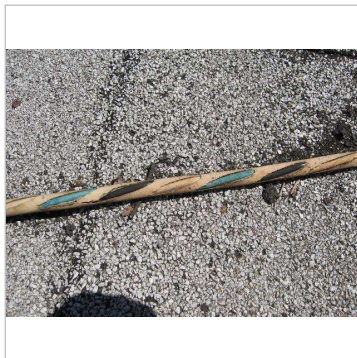
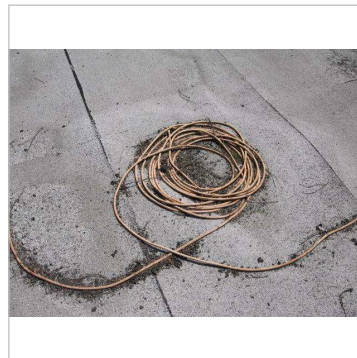
- 1.1.89 The exterior outlets should be upgraded to have ground fault protection, which is an essential safety feature that is mandated by current standards. on the roof.
- 1.1.90 An outlet on the roof wall is defective, but should be replaced with a ground fault protected type. There are temporary extension cords on the roof being used to power "christmas" lights that are seriously deteriorated and a hazard.

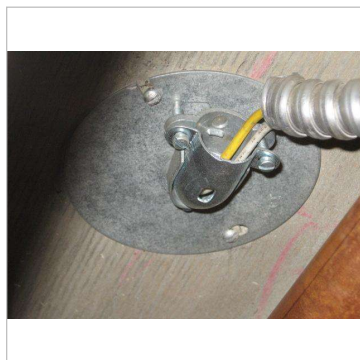
- 1.1.155 A representative number of lights were tested, and found to be functional. One ceiling floresant light over room 314 has loose electrical conduit with the wire exposed. This is most significant because it is the only wiring deficiency found on all the ceiling lighting.

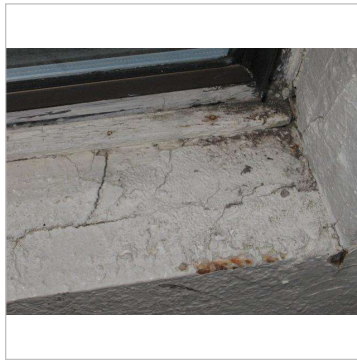
1.1.162 The window has a defect. The window sill is cracked and moldy indicating moisture intrusion.

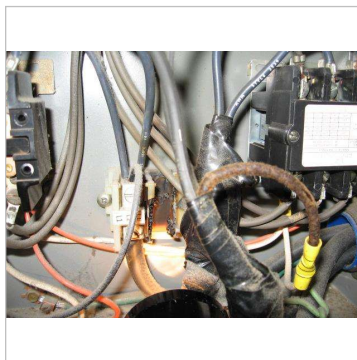
1.1.237 There are 2 commercial side load washers and 3 commercial side load dryers. They are in serviceable condition but of indeterminate age. The #1 Dryer has faulty wiring and a burned bus in the controlling sub panel.
