Shipshape Property

PROPERTY CONDITION REPORT

496 SW 257th St., Troutdale, OR,

INSPECTION DATE

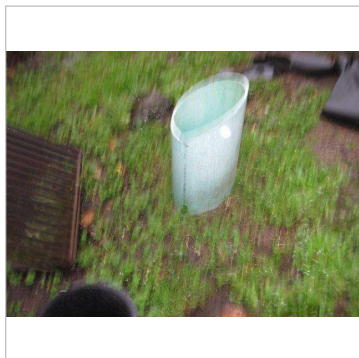
- 1.1.5 There is standing water or debris visible within the area drains, which is indicative of at least a partial blockage. There is an drain access open at the rear of the building that should be covered. It is currently a hazard for small children, a trip hazard and is open for debris contamination and blockage.

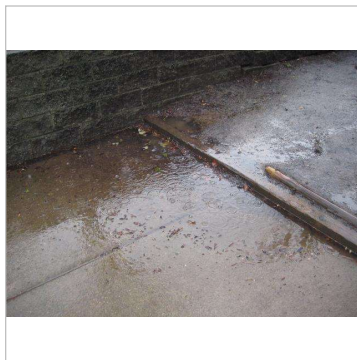
- 1.1.14 There are offsets in the walkways that could prove to be trip-hazards, which should be serviced. At the lower entry there is standing water. A drain should be installed or the walkway repoured to bring it back to a level surface.

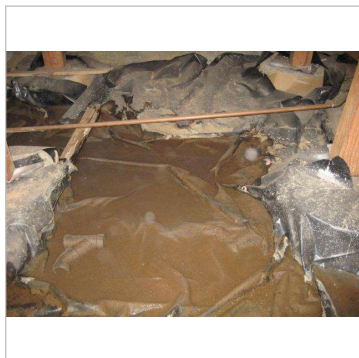
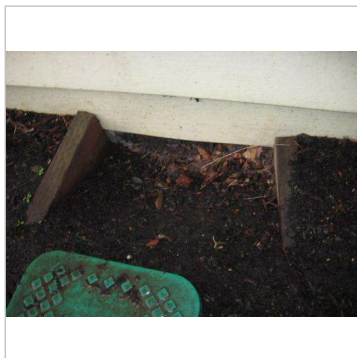
- 1.1.20 There is evidence that moisture has migrated under or through the stem walls of the raised foundation and stood in the crawlspace. This is apparent from standing water in the crawlspace. The crawlspace vent openings are below grade and water is flowing through them. They should be cleaned and serviced.

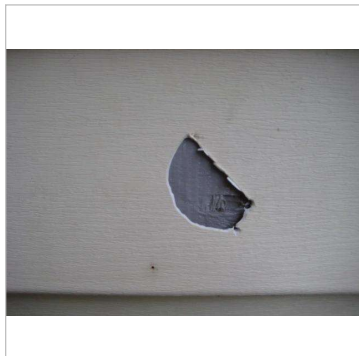
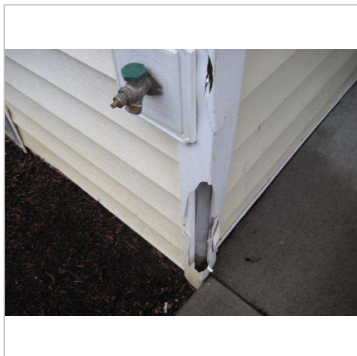
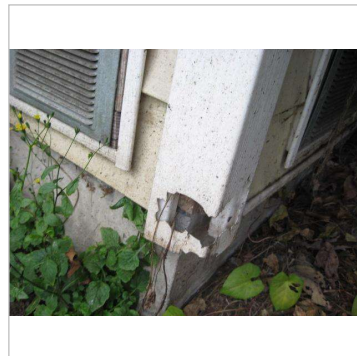
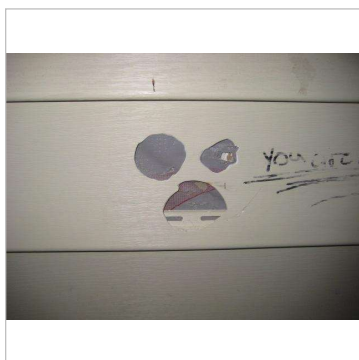
- 1.1.27 The siding is damaged in places and should be serviced. Overall the damage is minor but should be repaired because it poses an opportunity for moisture intrusion.

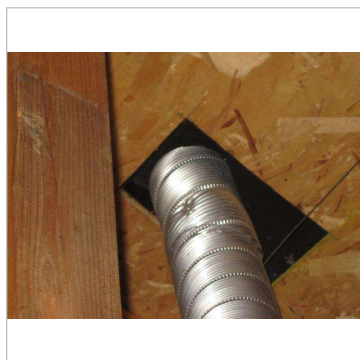
- 1.1.56 A bathroom exhaust duct vents within the attic, extended to an exterior port. **The vent ducting for all vents, in all buildings is flush with the roof vent. They are usually a foot or so away from the vent. This is allowing water, during blowing rain conditions to enter the duct and pass to the vent fan (Unit 64 has mold from this condition). Overall this is not showing to be a problem but it is a cuation that should be monitored and if moisture intrusion issues appear at the exhaust vents, this is probably the issue and the ducting should be moved.**

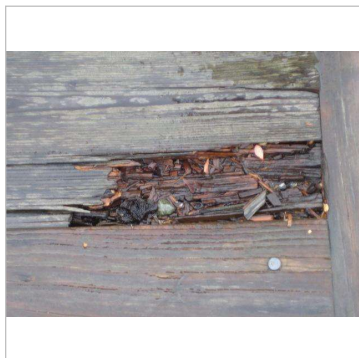
- 2.1.12 Entry components need service. The wooden entry steps, deck and ramp are weathered and need maintenance service. Stain/sealant service and carpentry maintenance will keep them up for a while but the entire system will need to be rebuilt within 3 years, it is already coming apart and there is early dry rot.

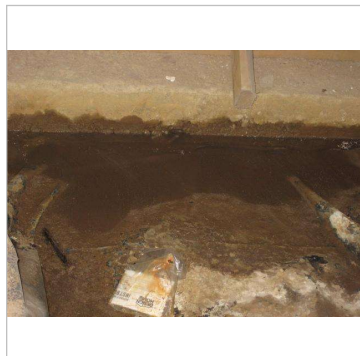
- 2.2.8 There is evidence that moisture has migrated under or through the stem walls of the raised foundation and stood in the crawlspace. This is apparent from standing water. It is likely a similar cause as building 496 and the damaged downspouts.

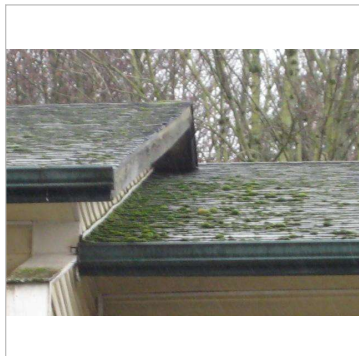
- 2.2.31 Fungus found on roof. This is a perennial problem in the Pacific Northwest and if not periodically cleaned off will reduce the service life of the roof materials. It is recommended that the roof be treated with and killed with fungicide (zinc sulfide), This will prevent moss from growing on the roof for some time.

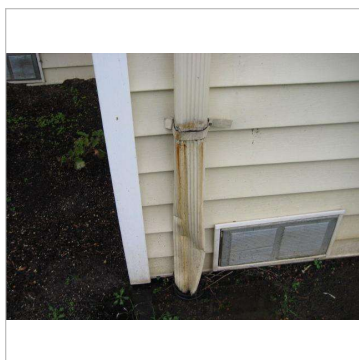
- 2.2.34 The gutters need to be cleaned and serviced to drain properly. Most of the downspouts from the gutter system on this building are damaged and should be replaced.

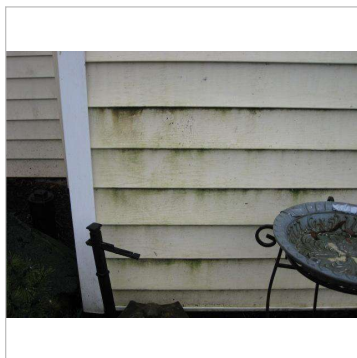
- 3.1.19 The siding is damaged in places and should be serviced. Overall the damage is minor but should be repaired because it poses an opportunity for moisture intrusion. There is also moss growing on the siding in places.

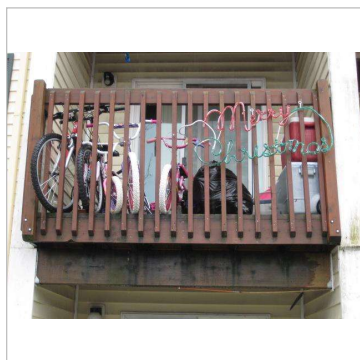
- 3.1.24 The balcony needs to be serviced or evaluated for the following reasons: The decks all need stain/seal service. The guardrails/walls need stain or paint service. The water passing through the decking is accumulating on the exterior and causing mold to grow and otherwise damage the building finish.

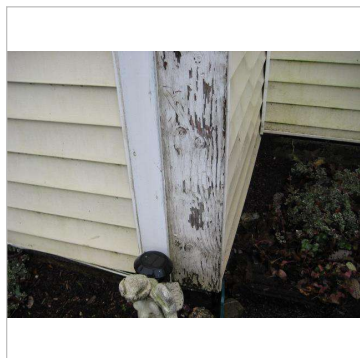
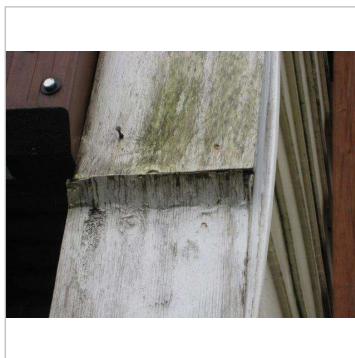
- 3.1.27 The wood trim is weathered and has dry rot.

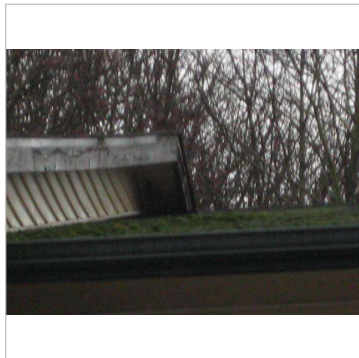
There is water coming into the roof and is apparent in the attic space over unit 22 & 25. The soffit is damaged (see photo) where the staggered roof comes together. This can probably be repaired by repairing the metal flashing, fixing the soffit and sealing the roof. Also refer to the Thermographic report on this building.

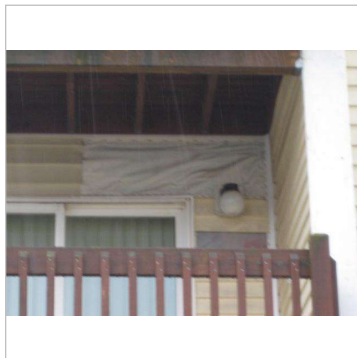
4.1.20 The siding is damaged in places and should be serviced. Overall the damage is minor but should be repaired because it poses an opportunity for moisture intrusion. There are 2 areas of missing siding in front of one 2nd floor unit.

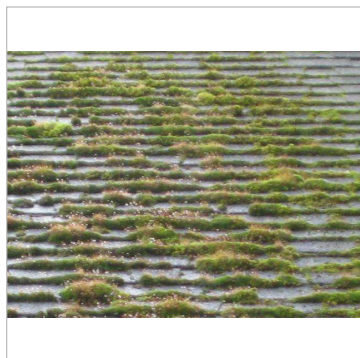
- 4.1.36 The roof needs to be cleaned to promote positive drainage, which is essential.
- 4.1.37 Fungus found on roof. This is a perennial problem in the Pacific Northwest and if not periodically cleaned off will reduce the service life of the roof materials. It is recommended that the roof be treated with and killed with fungicide (zinc sulfide), This will prevent moss from growing on the roof for some time.

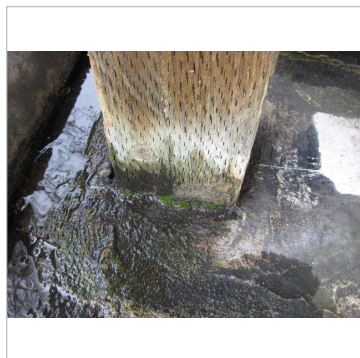
- 5.1.4 Based on occupancy status, the current parking space should be adequate. There are parking areas for this building that are covered. The metal roof is in good overall condition but the drainage is blocked in places it should be cleaned. Also the pressure treated wood posts for the awning have moss growing on the base. They should be cleaned off and sealed in order to preserve their service life.

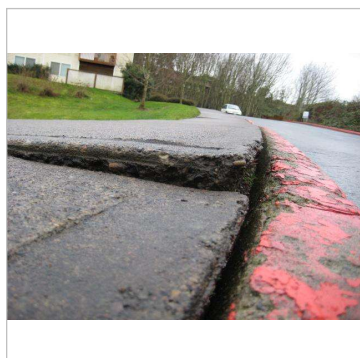
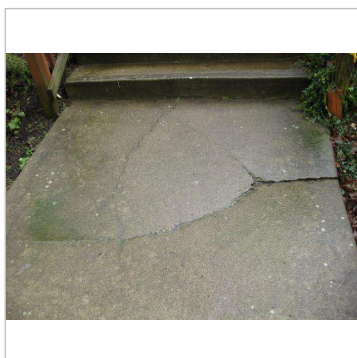
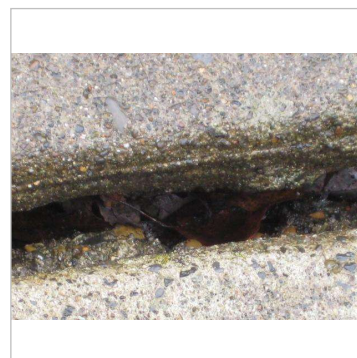
The Right entry has the same problem but is not as severe. It will undoubtedly need to be done as well but that can be monitored and put off for some time.

There are also concrete steps leading into both entries to this building that are beginning to settle and lean down. The upper crack/opening should be sealed to keep water out and exacerbating the problem and the level of the steps monitored. If the level or tilt down drops further the steps will have to be re poured at considerable expense.

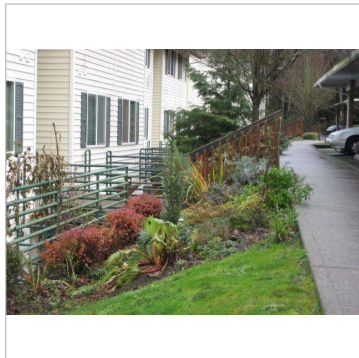
- 5.1.26 One handrail is loose and should be secured for safety reasons. most of the exterior handrails are wooden and weathered. All require stain service, some should be replaiced. There is an area in front of this building and the next Bld. 628 as well that slopes steeply away from the walkway and there should be a safety guardrail installed.

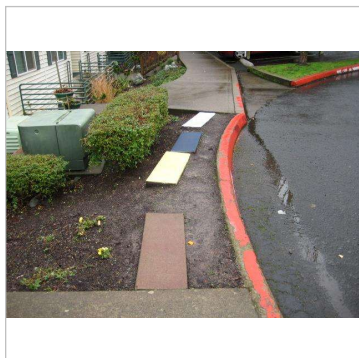
- 6.1.7 There are offsets in the walkways that could prove to be trip-hazards, which should be serviced. There is a makeshift walkway between 606 and 628 consisting of narrow concrete blocks. As they are they encourage people to use them but they are incomplete and constitute a trip hazard. The blocks should be removed or the walkway completed.

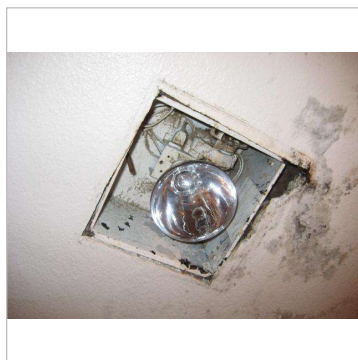
- 6.4.22 There is a moisture stain on the ceiling, which should be explained or explored further. Around the exhaust fan there is moisture and mold. Mold should be remediated, exhaust fan replaced, drywall repaired and fan ducting moved.

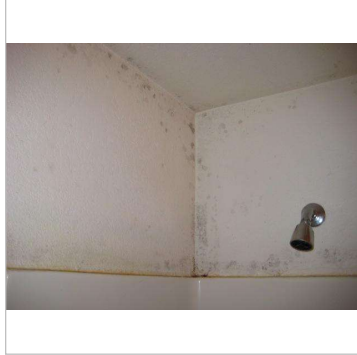
- 6.4.23 Mold found in the Tub/shower area.

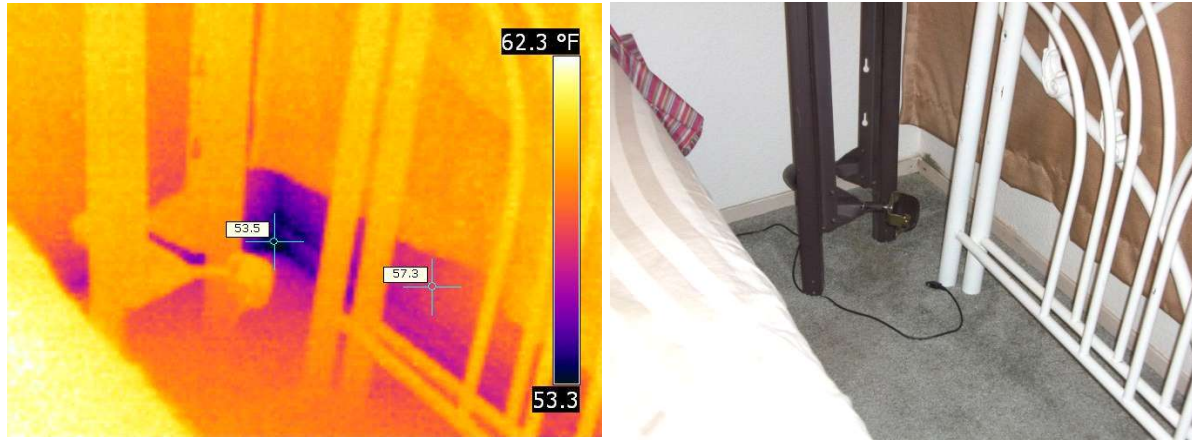
BUILDING # 540	UNIT # 26	INSIDE TEMP: 61	
-----------------------	------------------	------------------------	--

DESCRIPTION: These anomalies are typical of moisture wicking up the wall. There are known moisture penetration issues in this room. Attempts have been made to correct the issues, however, they were unsuccessful. Recommendations would include locating and correcting the moisture source and removing the wall board to dry out the structure within.

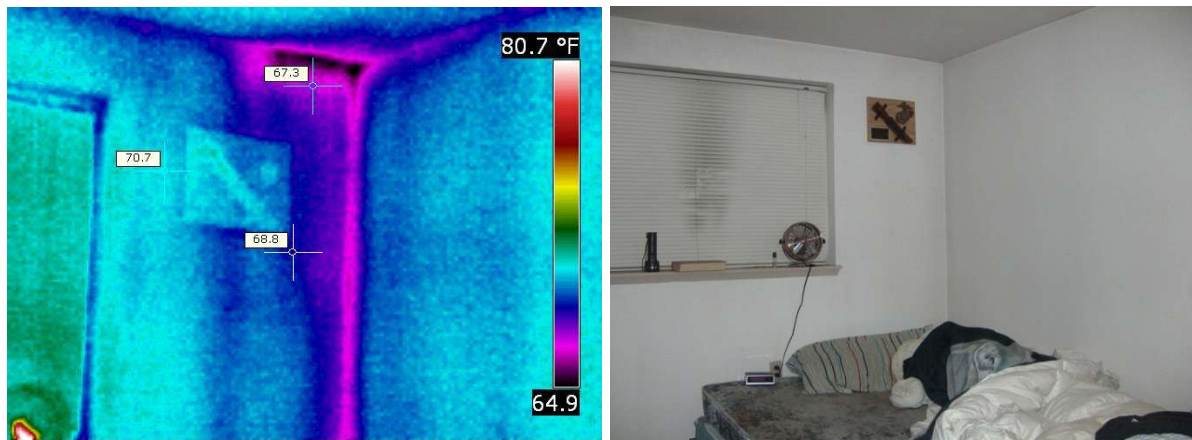
BUILDING # 540	UNIT # 23	INSIDE TEMP: 61	
DESCRIPTION: There is visible mold growth in the corner of this wall. The thermogram shows moisture wicking up the wall. The window treatments and furnishings prohibited viewing the upper section to identify if the moisture was entering from above the floor line. There is currently a moisture entry issue at this location.

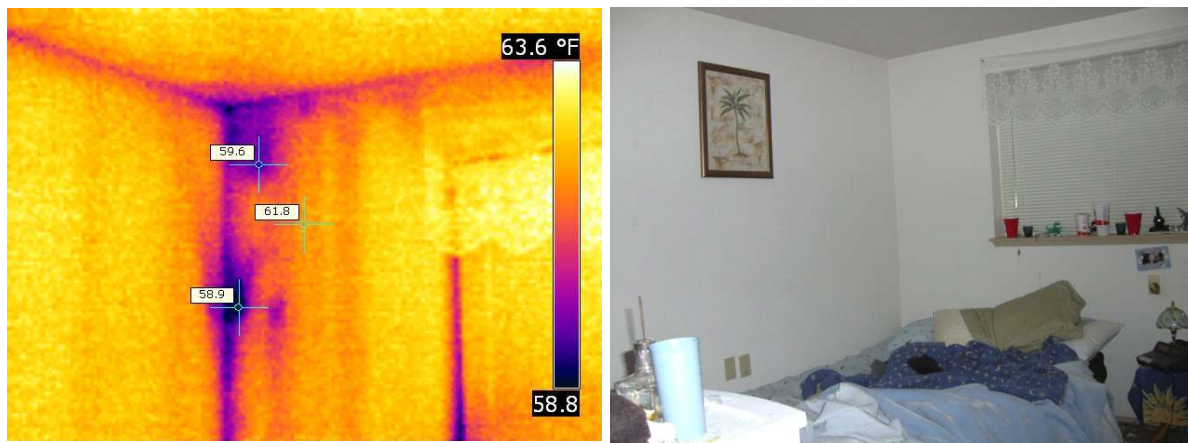
BUILDING # 606	UNIT #50	INSIDE TEMP: 63	
DESCRIPTION: This anomaly is typical of moisture cascading down a wall. Further investigation is needed to confirm. The area mentioned is the darker blue and not the red-pink corner as most corners will show colder.

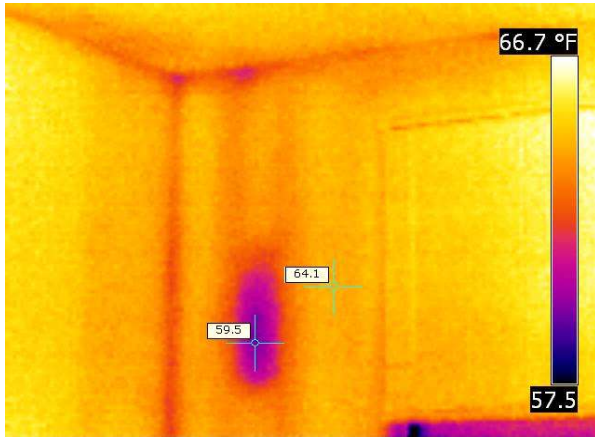
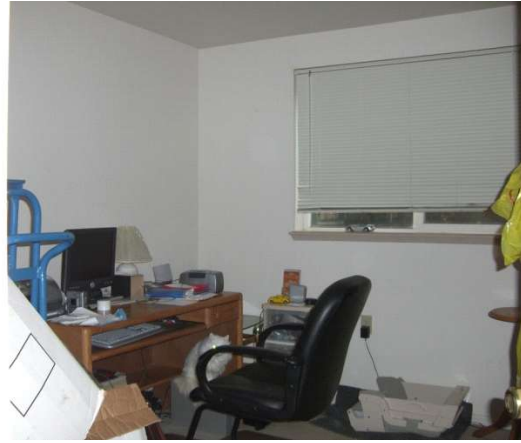
BUILDING # 606	UNIT # 41	INSIDE TEMP: 62	
DESCRIPTION: The anomaly found in this room is typical of possible missing insulation. Further investigation will be needed to confirm.

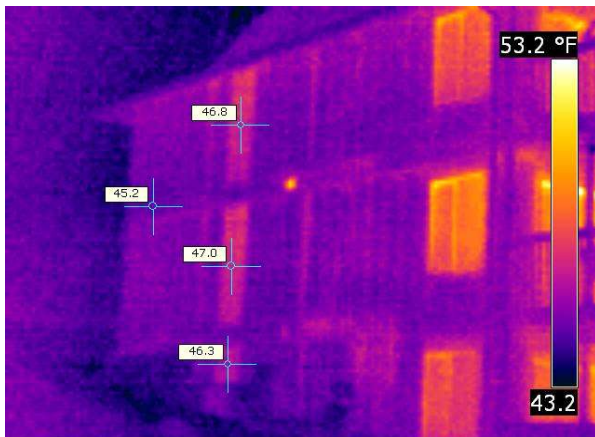
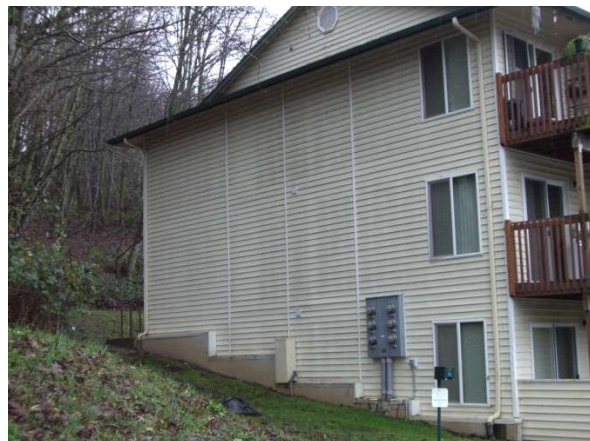
BUILDING # 628	UNIT # 53	INSIDE TEMP: 62	
DESCRIPTION: This anomaly is possibly damp insulation wicking moisture from the exterior concrete wall. Directly on the exterior of this wall is a subsurface drain. Further investigation will be needed to verify if moisture is present.

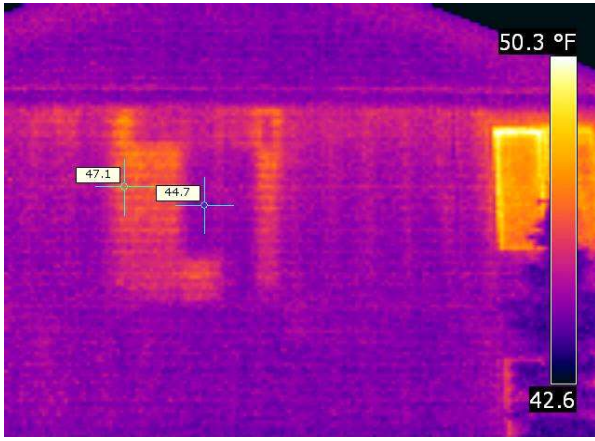
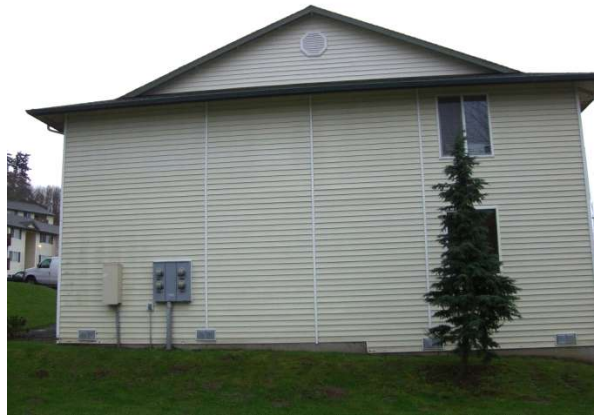
BUILDING # 628	UNIT # East Side	INSIDE TEMP: NA	
DESCRIPTION: The east side of building #628 shows an anomaly consistent with un insulated bays. The areas in question are at the location where the interior showers back up to the exterior wall. This could be the cause the anomaly, however no other buildings showed this type of anomaly. Non insulated bays may cause condensation within the wall.

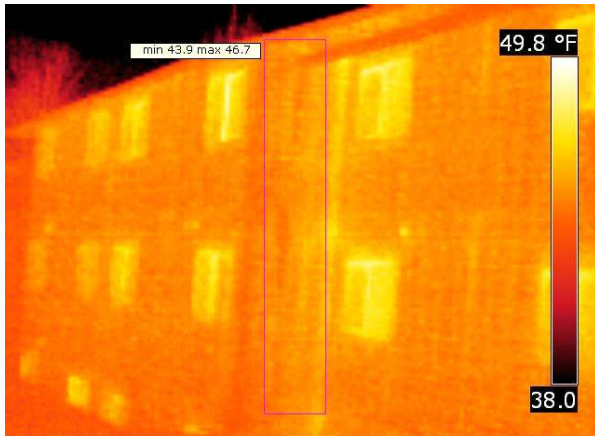
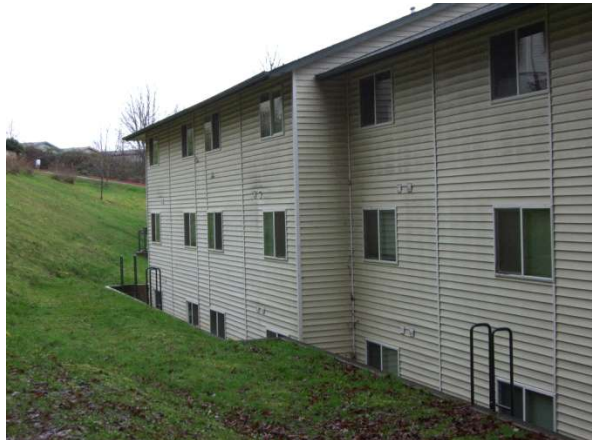
BUILDING # 496	UNIT # East Side	INSIDE TEMP: NA	
DESCRIPTION: This is also an area believed to be missing insulation.

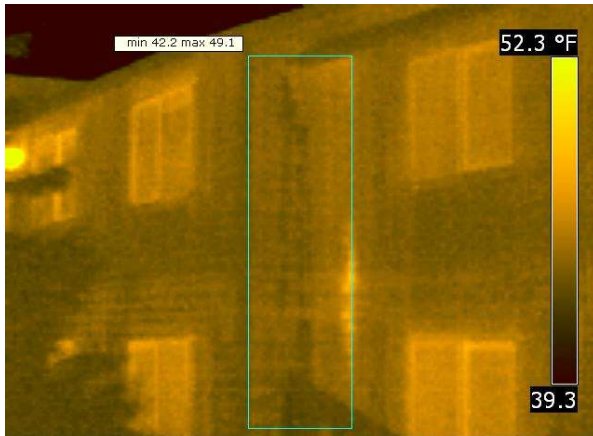
DESCRIPTION: This image shows excessive moisture running down the outside wall cladding. The cause is likely a poor roof to wall connection. Provisions to divert roof water into the gutter are recommended. This will also aid in preventing excessive moisture in the egress wells. NOTE: The lower unit corner is unit #20 where moisture was identified. The second thermogram is from building # 628. Most of the roof to wall connections are allowing water to run down the exterior.
