Propertyexam corp. Thermal Imaging Inspection Report

High School

6/7/16

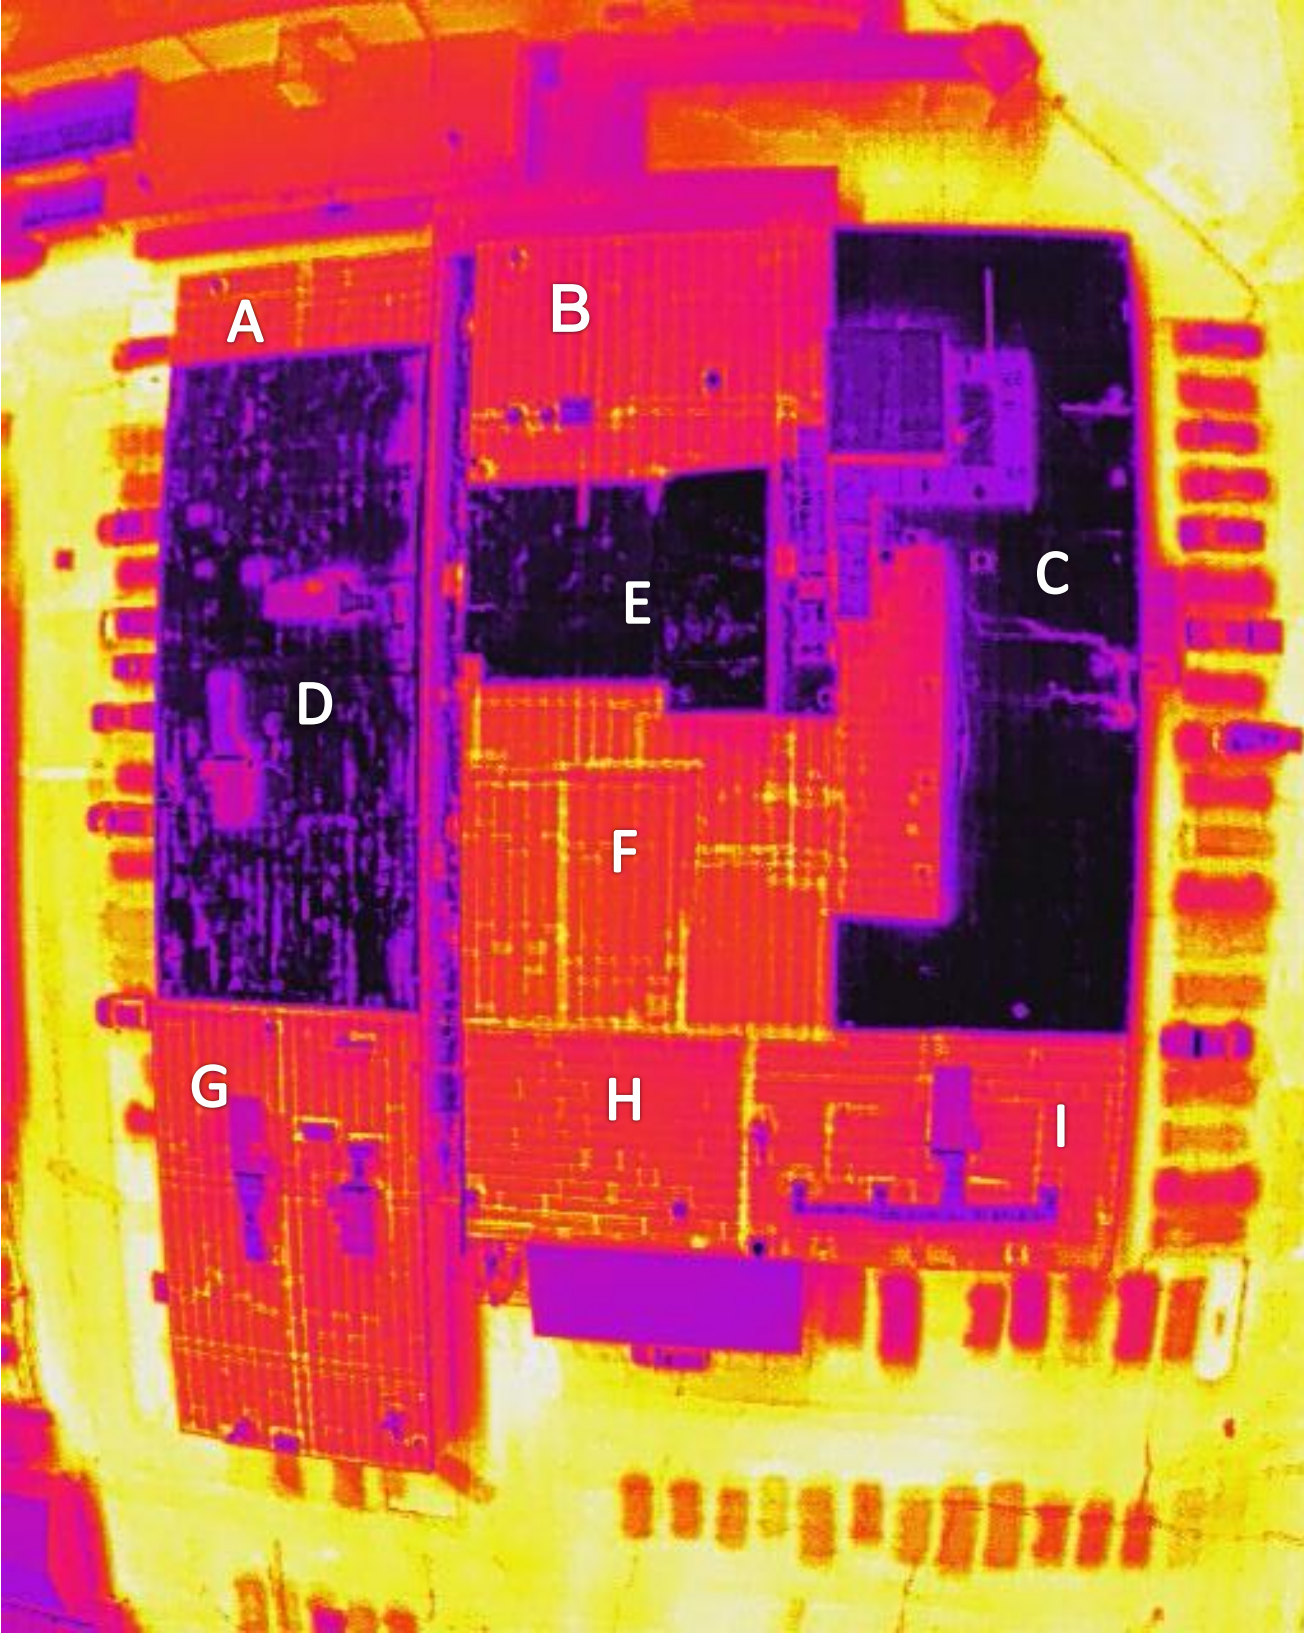
Analyzed section

The methodology for thermal analysis of roof systems is done at the end of the day when the ambient air cools and the roof system cools. Areas with entrapped moisture show up as hot areas where the moisture retains the heat built up during the day. The colors go from dark to orange to yellow cold to warm. This image also shows entire sections that show up as “warmer” overall than others because these areas are covered with a silver seal coat. The warmer or more moisture laden areas within these sections show up as yellow. Basically this is a “relative” heat concept. Where there are areas that show up as warmer than the surrounding areas, that is an indication of entrapped moisture.

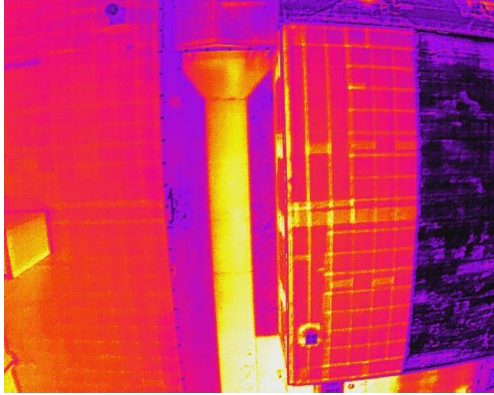
A

Section A: This is a silver coated area. There is an indication of some entrapped moisture in the middle running vertically.

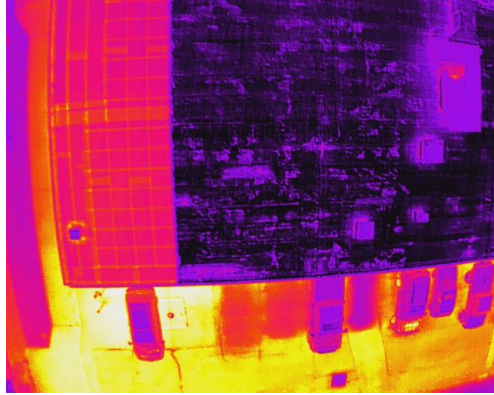
AB

Section B: This is a silver coated section, overall it is in fair/good condition. The small yellow areas are sealant at seams.

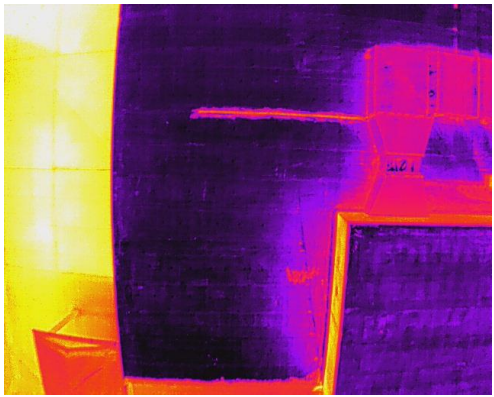
C

Section C: Overall this section is in fair condition. There are some small areas in the middle running right to left that are beginning to break down showing some moisture entrapment but overall very little.

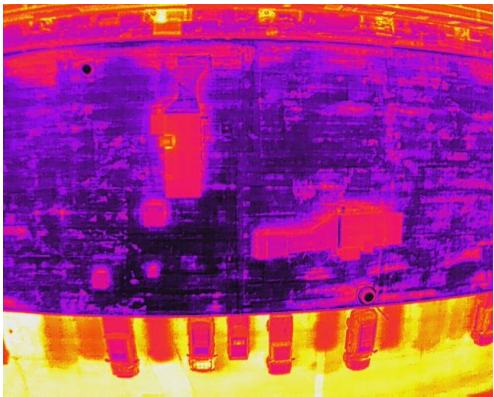
D

Section D: This is the worst section of the roof. There is pervasive entrapped moisture indicated in this section.

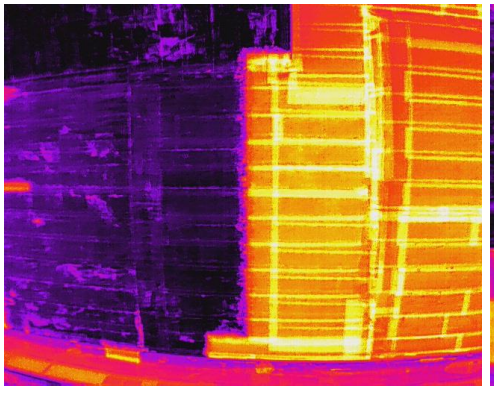
EF

Section E: There is significant entrapped moisture indicated in this section.

Section F: There may be some initial breaking down of the roof sections and some entrapped moisture is indicated. However, most of the indicated hot areas correspond with seams that have heavy sealant. The areas that appear yellow, that do not correspond with seams indicate entrapped moisture.

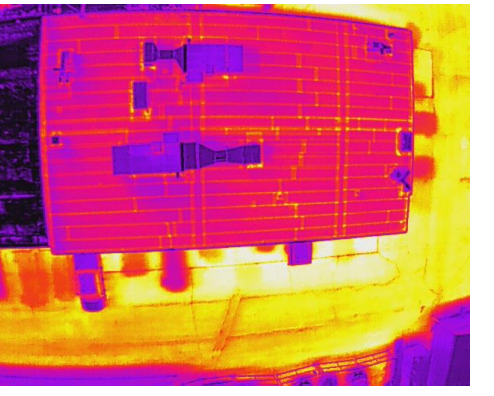
G

Section G: There may be some initial breaking down of the roof sections and some entrapped moisture is indicated. However, most of the indicated hot areas correspond with seams that have heavy sealant. The areas that appear yellow, that do not correspond with seams indicate entrapped moisture.

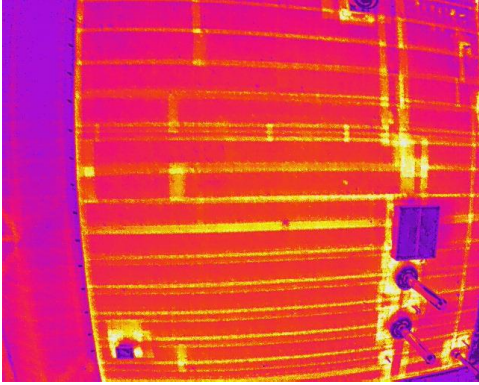
I

Section I: There may be some initial breaking down of the roof sections and some entrapped moisture is indicated. However, most of the indicated hot areas correspond with seams that have heavy sealant. The areas that appear yellow, that do not correspond with seams indicate entrapped moisture.
