Inspection Report

Property Address:

somewhere
sometown OR

Date: Invalid DateTime	Time:	Report ID: Hotel Sample 2
Property: somewhere sometown OR	Customer: someone	Real Estate Professional:

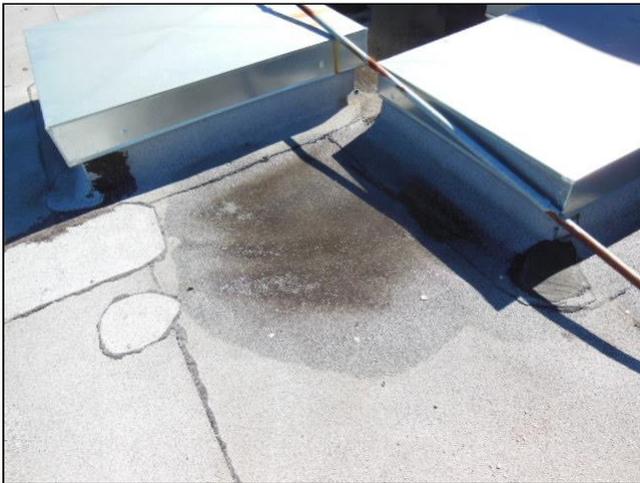
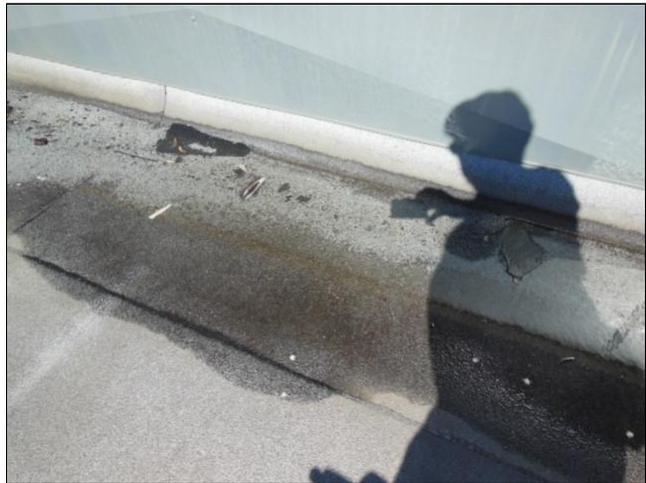
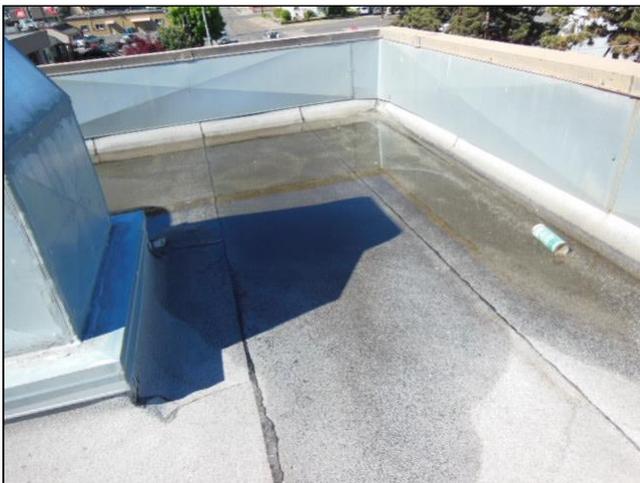
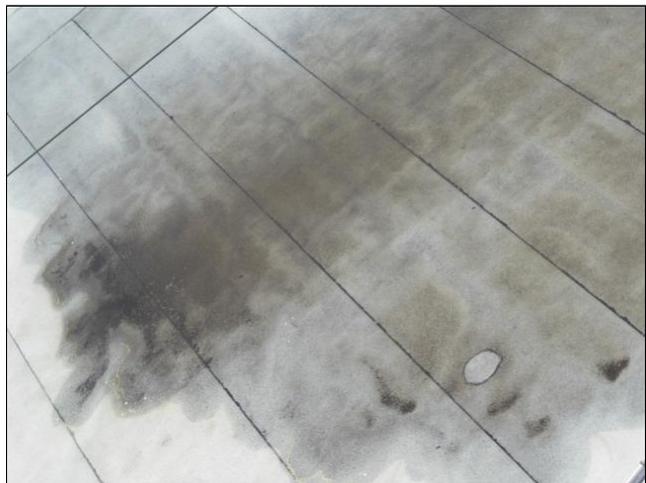
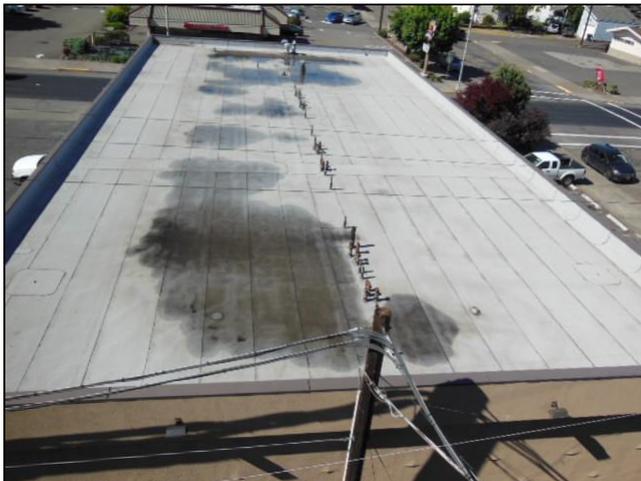
1.0 ROOF COVERINGS

(1) As the roof approaches the end of its useful life, it will require seal service and patching to remain water tight. We recommend that when it does get replaced, it be replaced with a TPO style roof. This roof will cost a little more to install (about \$85,000) but will last longer and require less maintenance. Therefore, over the life of the roof, a TPO roof will cost considerably less.

You should get more than 5 years out of the existing roof with proper maintenance. There are some areas of standing water that need particular attention and will likely need patch repair over time. The roof of both buildings are in similar condition.

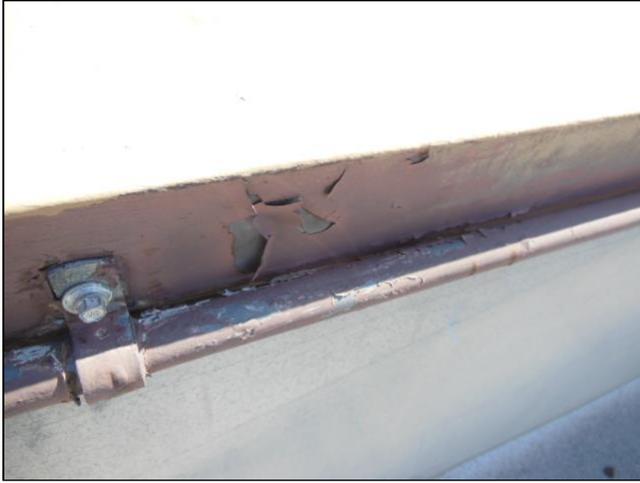
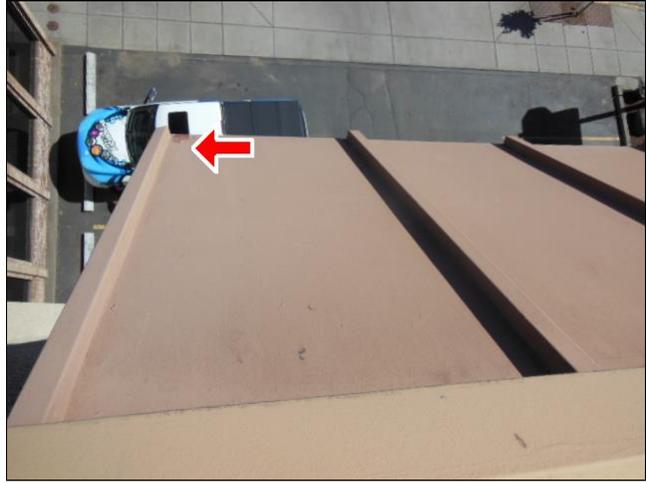
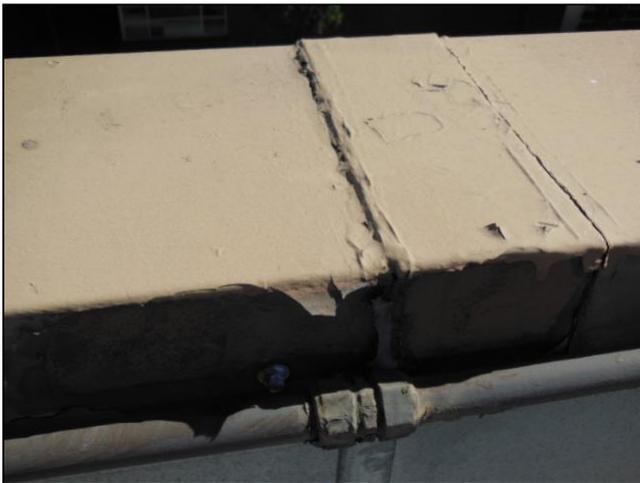
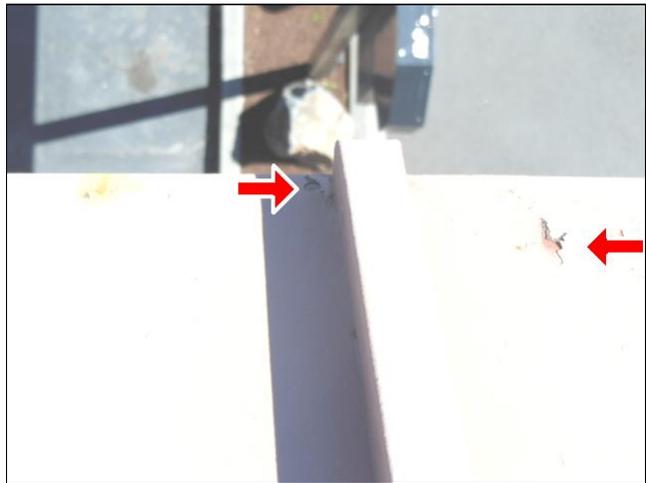
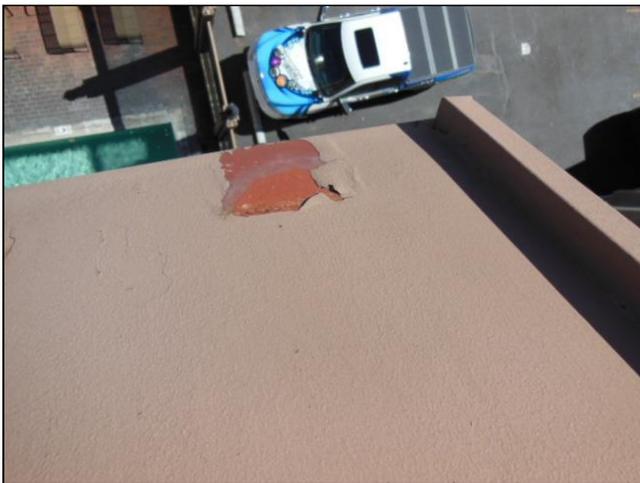
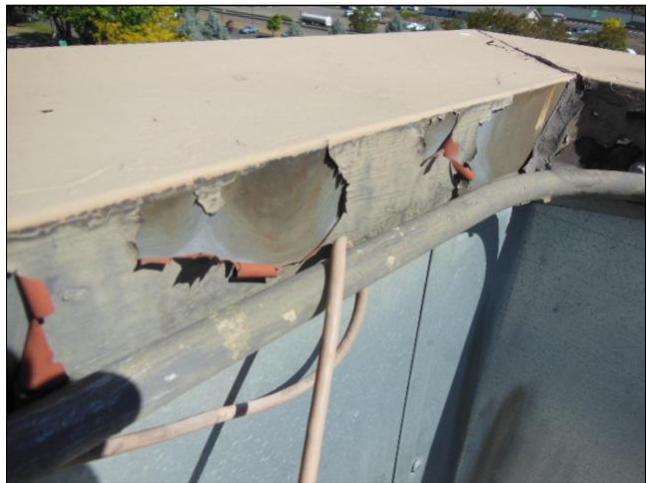
1.1 ROOF FLASHINGS

Roof Parapets and overhang awnings due for paint seal service. Paint is failing.

Roof Parapets and overhang awnings due for paint seal service. Paint is failing.
\$2,500 - \$3,000

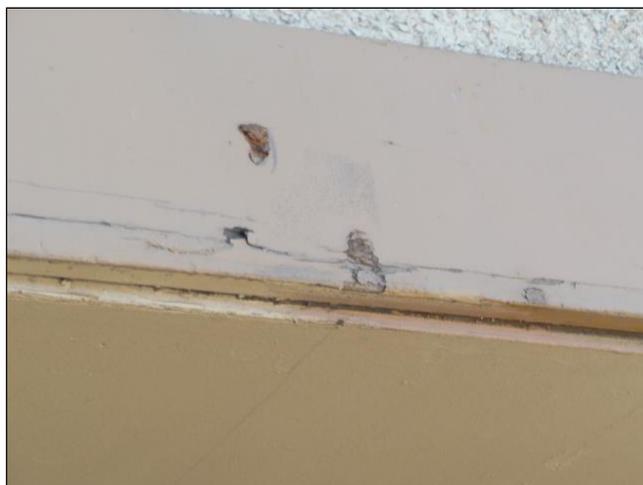
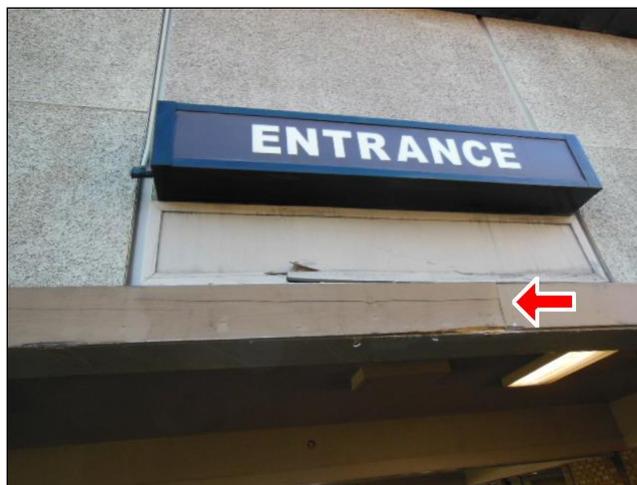
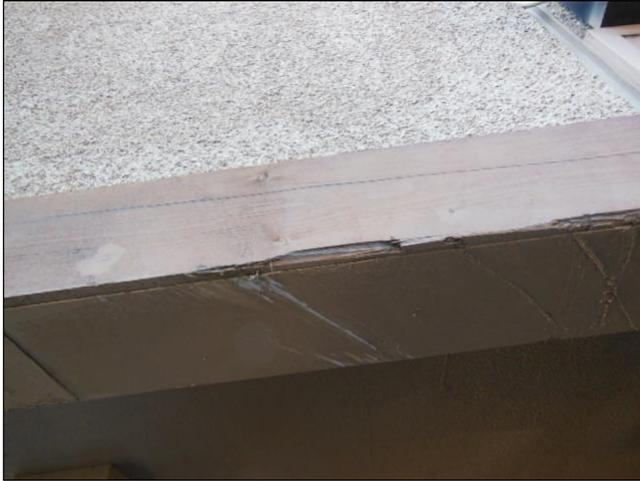
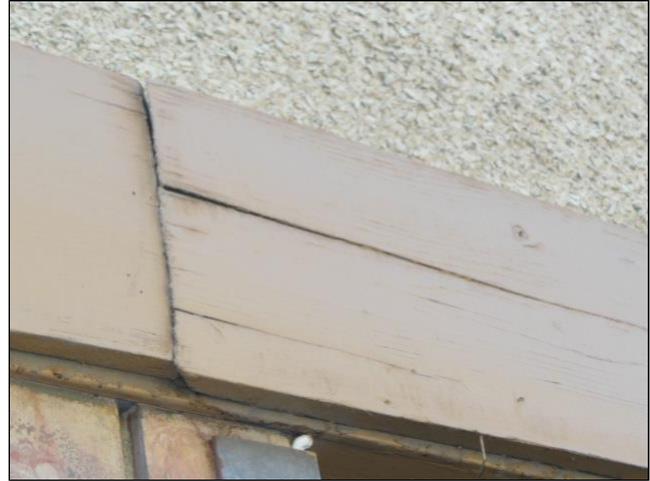
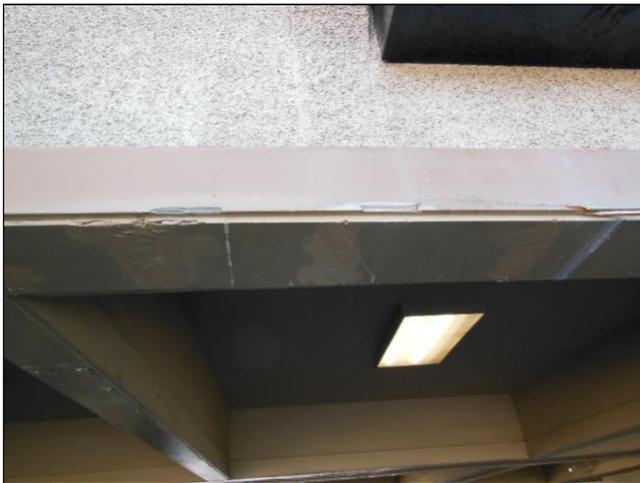
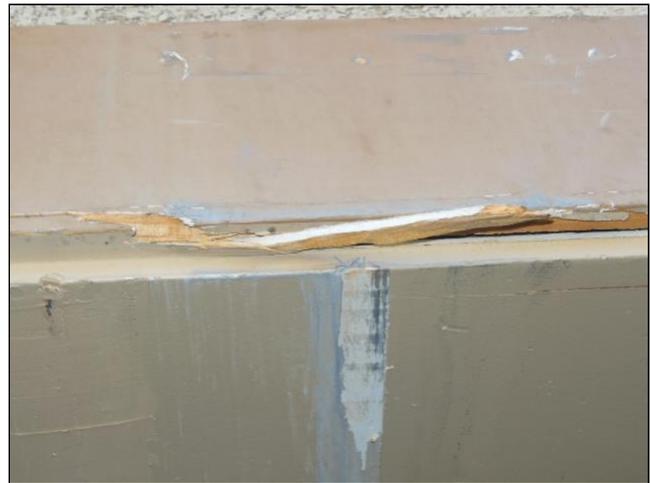
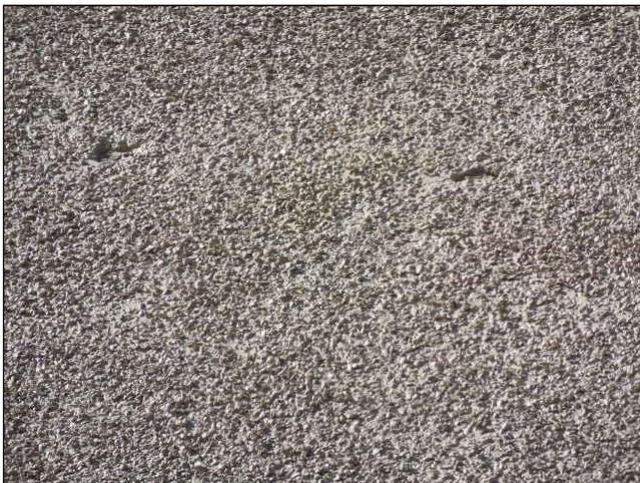
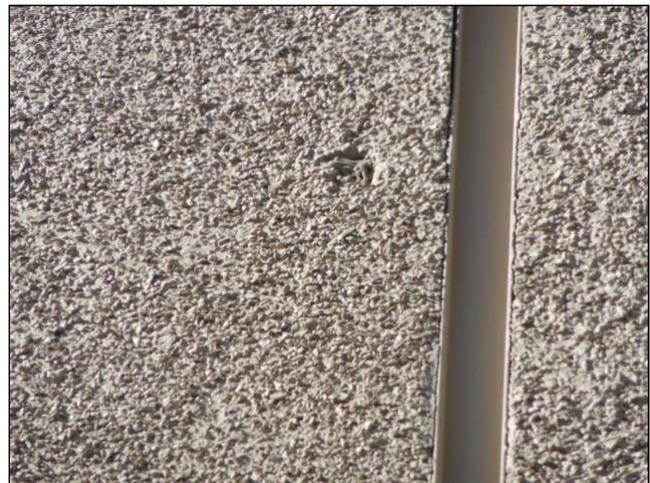
2.0.A WALL CLADDING FLASHING AND TRIM

(1) Overall the exterior cladding is in good condition . There is some weathering of the exposed wood trim on the exterior that needs touchup paint seal service now and repainting within 3-5 years. There are a few typical minor mechanical damage areas to the stucco.

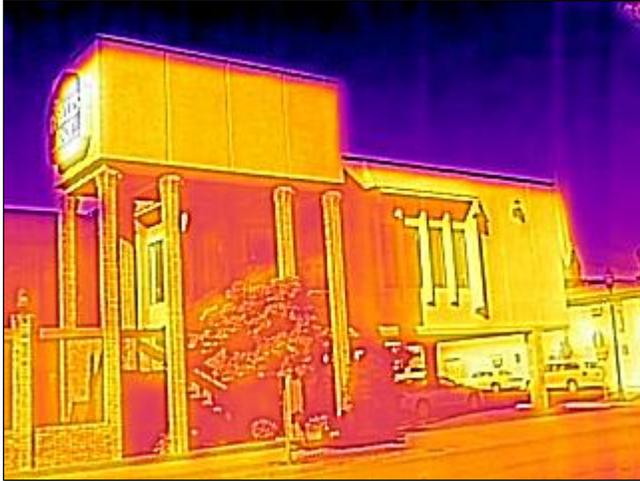
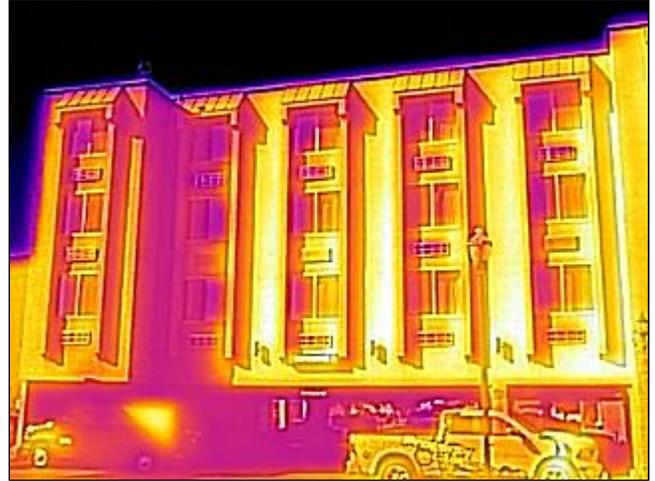
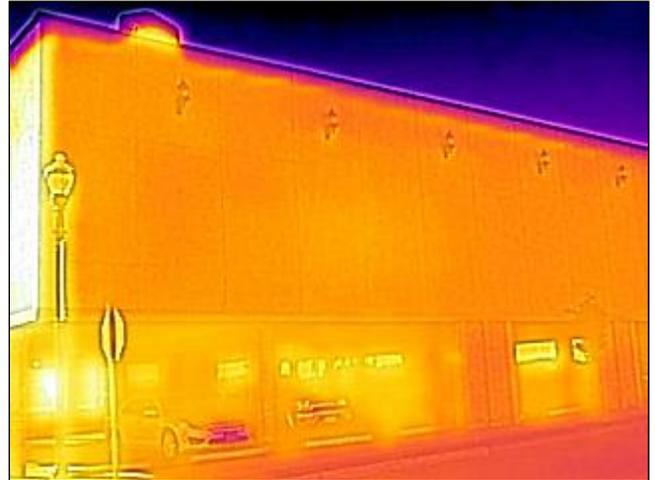
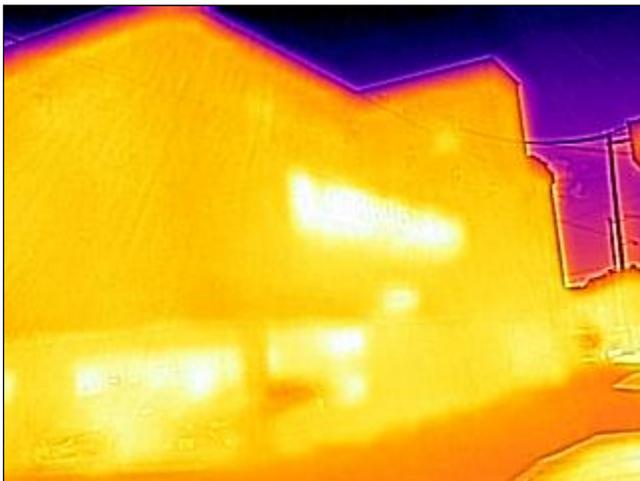
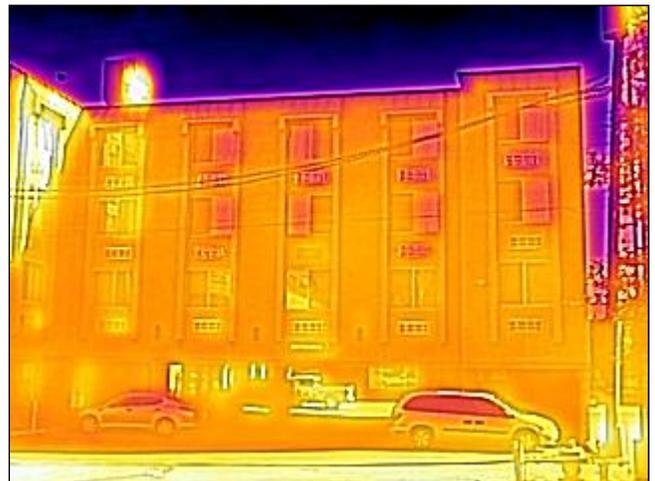
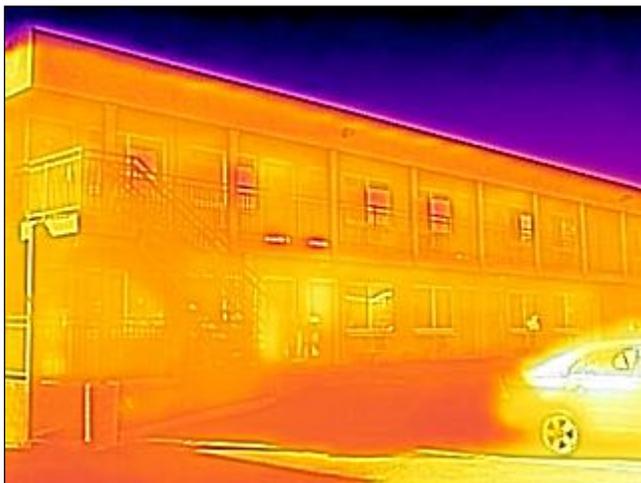
(2) **Complete Building envelope Thermal Imaging Scan for Moisture Intrusion Issues.**

A thorough Thermal Imaging moisture scan was conducted and analyzed of the structure. All exterior walls, were scanned from the interior. The entire roof envelope was scanned analyzed. All suspect areas were also checked with an electronic, non destructive moisture meter. In all of the tested areas, there was no evidence of moisture intrusion found at the time of the inspection except where otherwise noted.

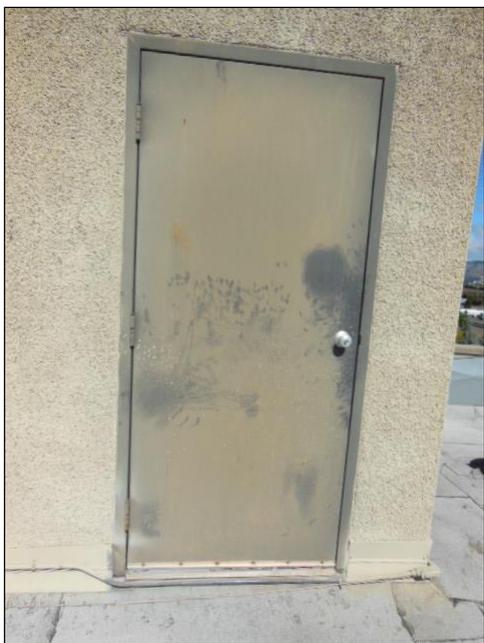
2.1.A Item 1(Picture)

Exterior side utility door (wood), delaminating at base, recommend replacement. Roof access door corroding, needs paint and hardware repair service.

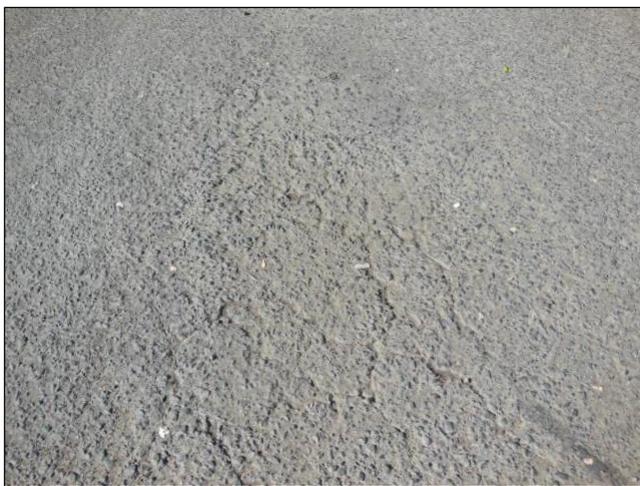
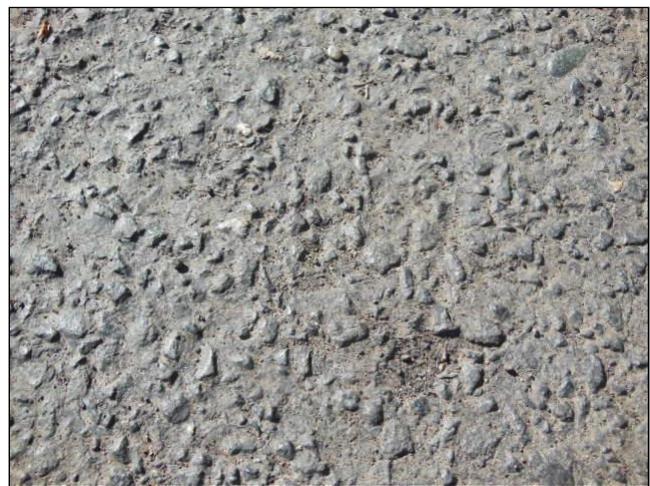
2.7.A Driveway & Parking

The asphalt parking due for seal service. We recommend asphalt surfaces be seal serviced about every five years in this climate. Neglect will result in " alligator cracking and deterioration. Ultimately the surface will need to be resurfaced with a 2" overlay of new asphalt. The difference in cost is about \$0.18/SF for seal service and \$2.00 SF for an overlay

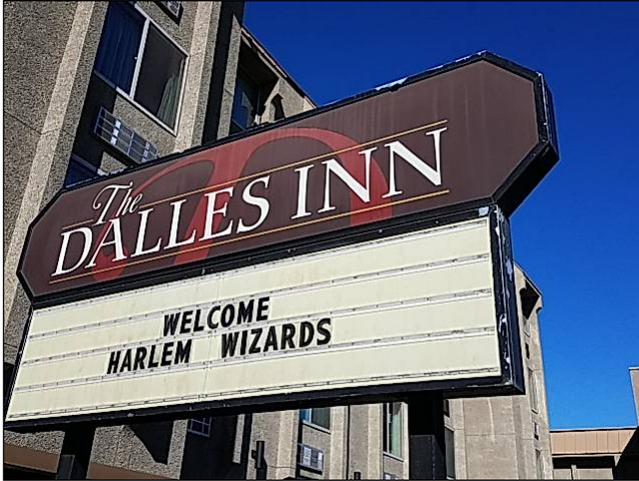
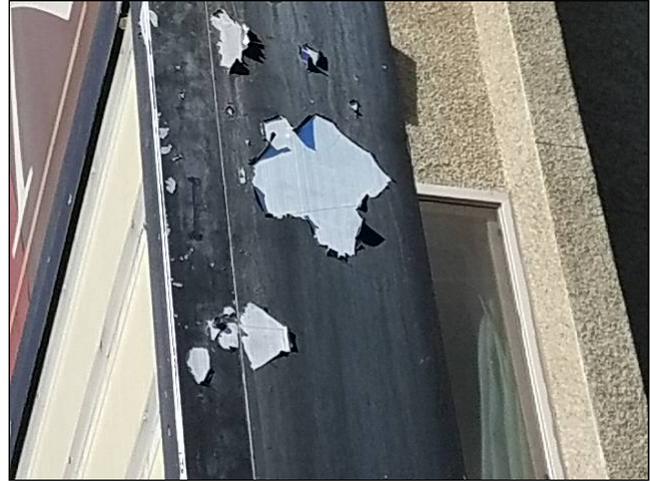
2.8.A Signage

Lower sign at northeast corner needs paint service.

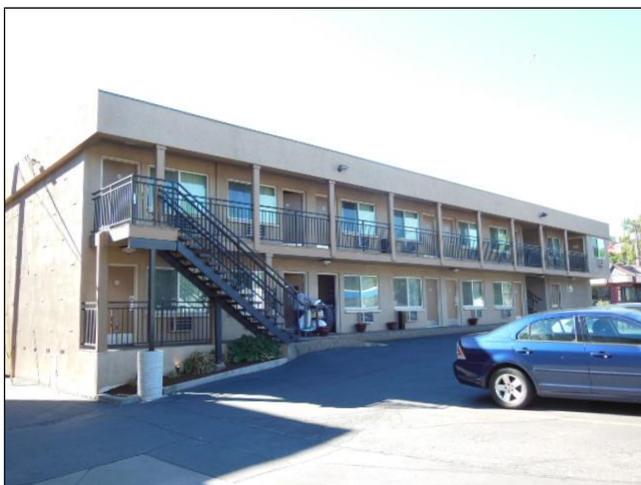
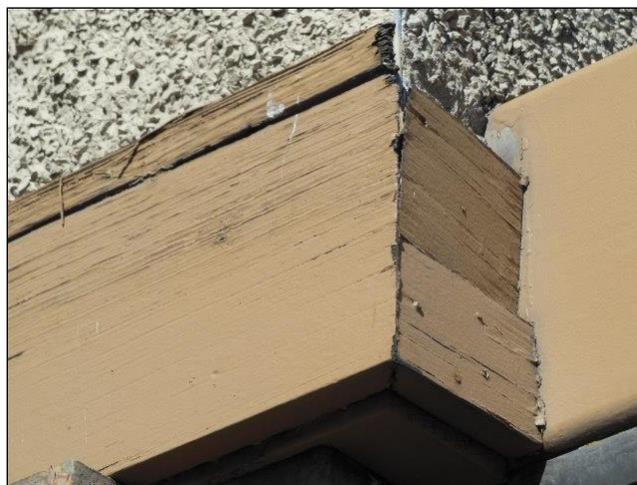
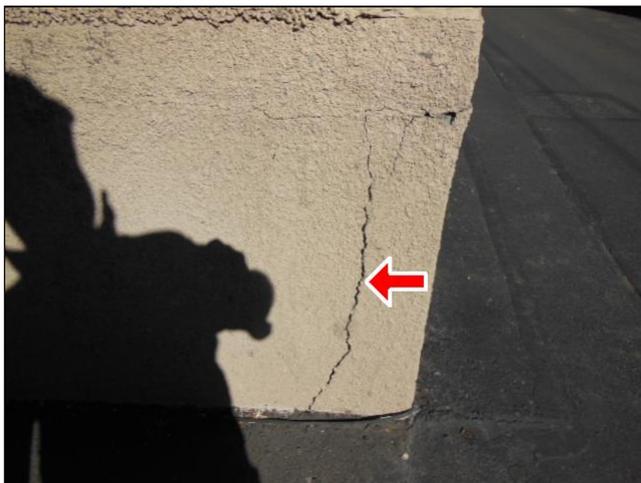
2.0.B WALL CLADDING FLASHING AND TRIM

(1) Cracks in stucco northeast & northwest corners need to be patched repaired and sealed. Exposed wood due for touch up paint service repainting 2 to 3 years.

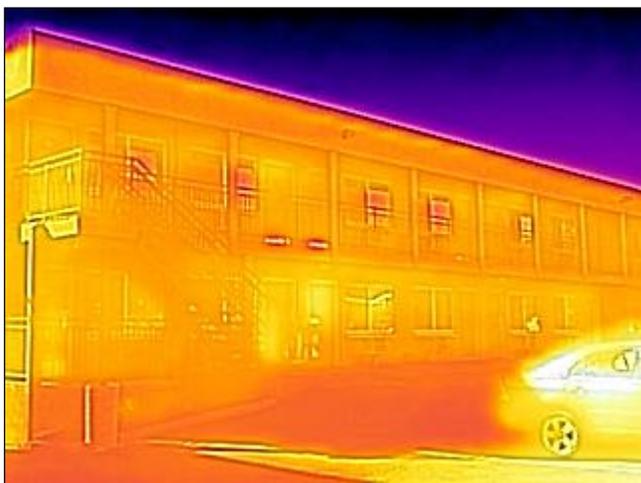
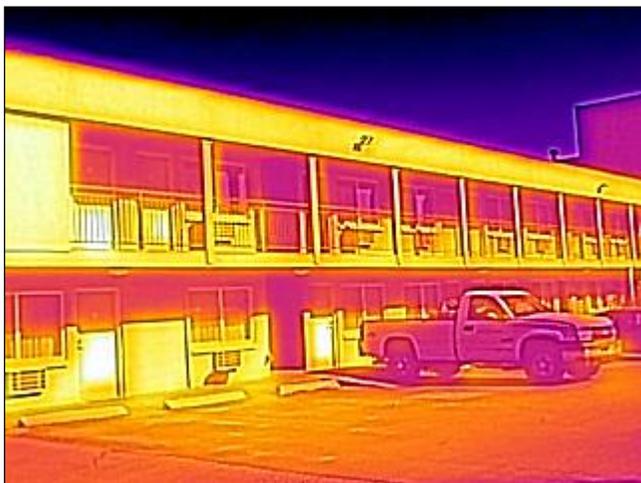
(2) Complete Building envelope Thermal Imaging Scan for Moisture Intrusion Issues.

A thorough Thermal Imaging moisture scan was conducted and analyzed of the structure. All exterior walls, were scanned from the interior. The entire roof envelope was scanned analyzed. All suspect areas were also checked

with an electronic, non destructive moisture meter. In all of the tested areas, there was no evidence of moisture intrusion found at the time of the inspection except where otherwise noted.

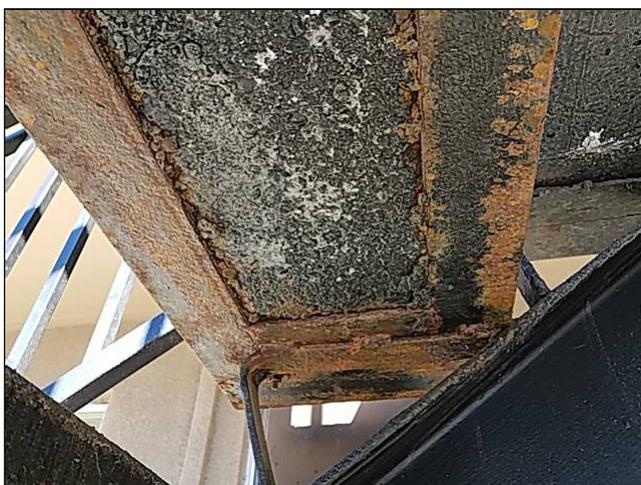
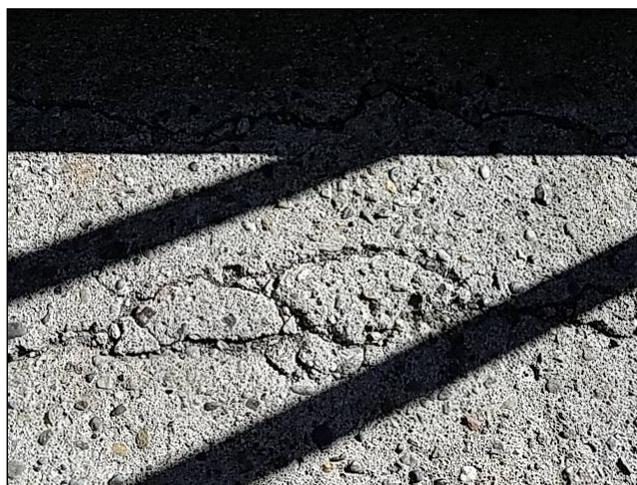
2.3.B DECKS, BALCONIES, STOOPS, STEPS, AREAWAYS, PORCHES, PATIO/ COVER AND APPLICABLE RAILINGS

Metal steps to second floor corroding . Some concrete filler steps broken can be a trip hazard. Recommend corrosion remediation of the steps, demo/refilling broken concrete (2 steps) and repainting of all stair and guard rail steel.

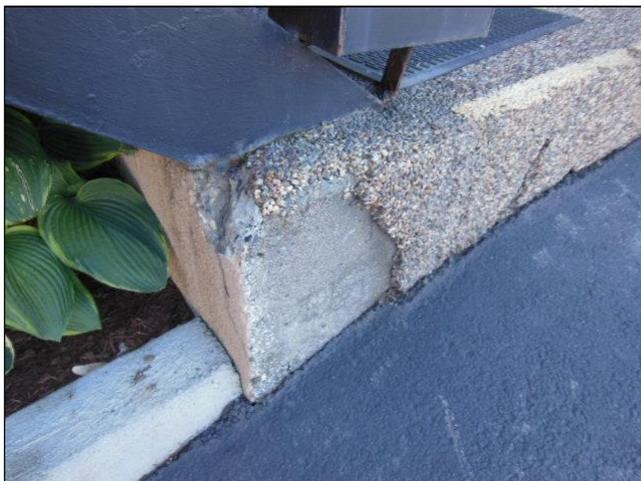
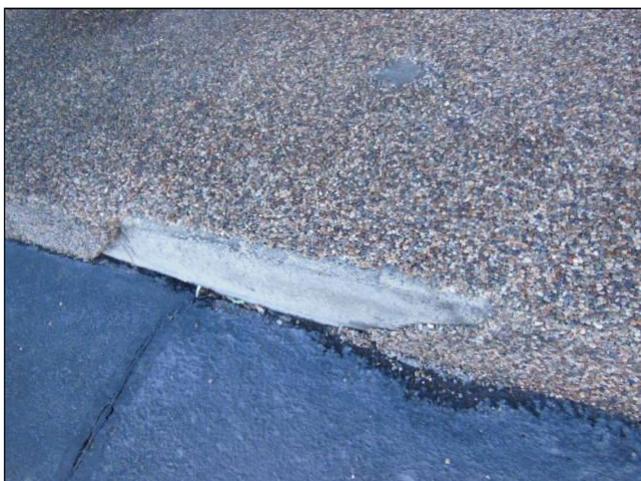
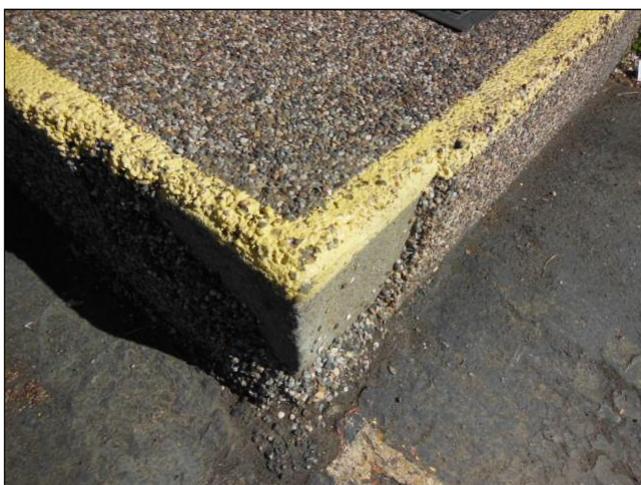
2.6.B Flatwork

Most of the exterior walkways and balcony surfaces are covered with aggregate stone and epoxy mix. There are areas where this is beginning to break away and crumble. This material is notorious for being an ongoing maintenance problem . It can be patched/repared but this will likely be an ongoing issue with this property . Our best recommendation is to demo the aggregate stone/epoxy surfaces and repair the underlying concrete as needed.

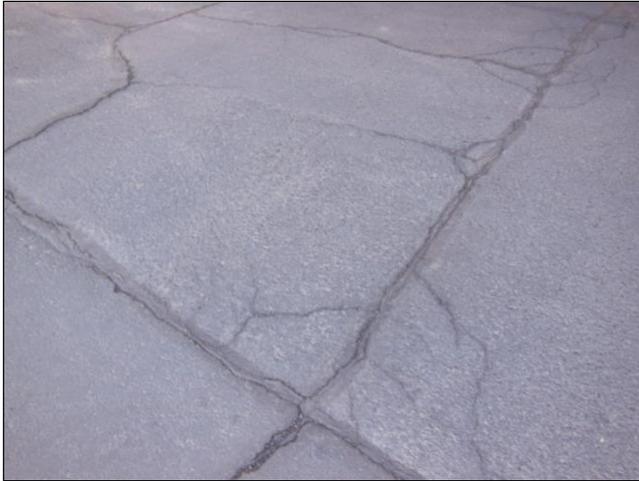
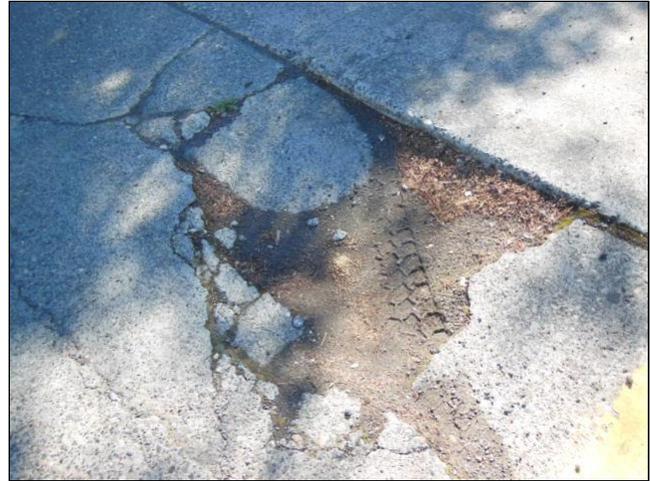
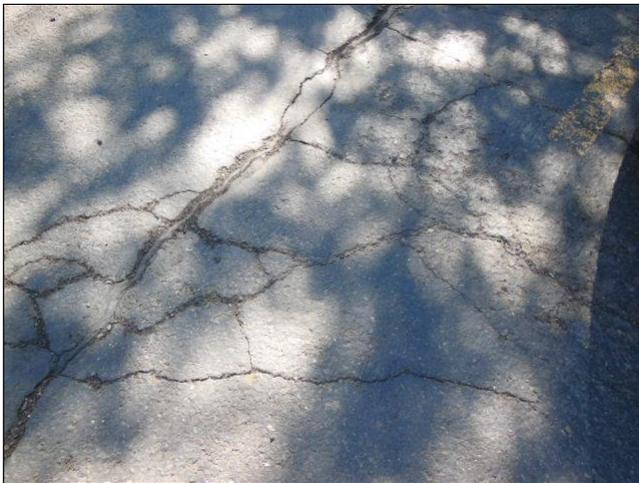
2.7.B Driveway & Parking

Parking area asphalt neglected, well past due for patching and seal service . This parking lot is in worse condition than the main building although it can be patched repaired it will not have a good clean surface unless it is resurfaced. Our recommendation is to plan for a 2" overlay and patch repair the entry concrete.

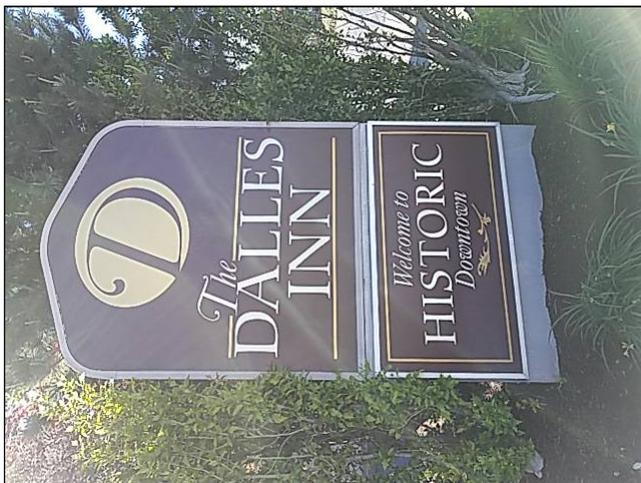
2.8.B Item 1(Picture)

Signage acceptable.

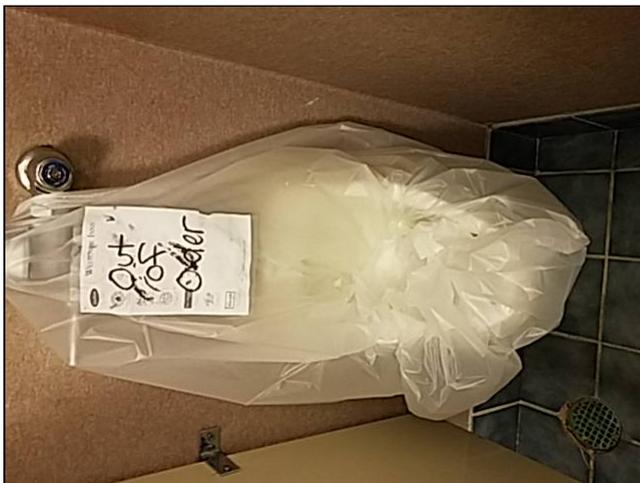
4.1 Item 1(Picture)

men's urinal 2nd floor out of order

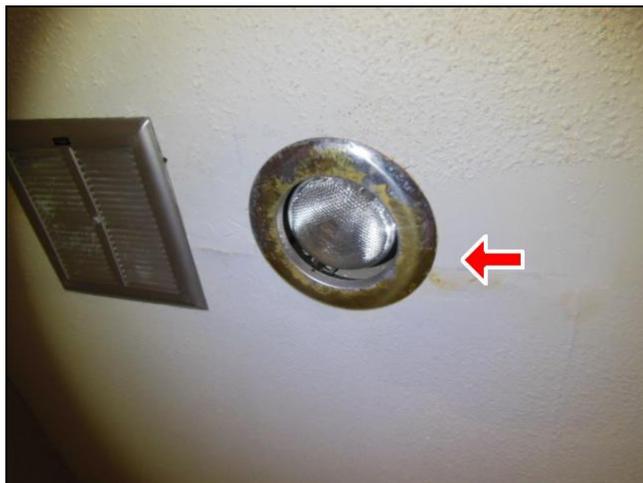
7.0 Item 1(Picture)

typical cosmetic damage drywall.

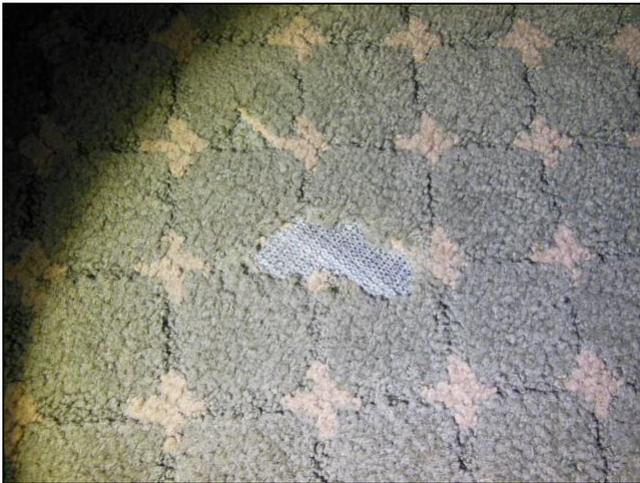
7.2 Item 1(Picture)

- (1) Carpet worn throughout Main building units. S Annex units carpet newer, more "industrial grade".
- (2) S Annex. 2nd floor SE rooms all seem to have cracked tiles in the bathroom. This is the likely result of settling. These broken tiles could be demolished and replaced.

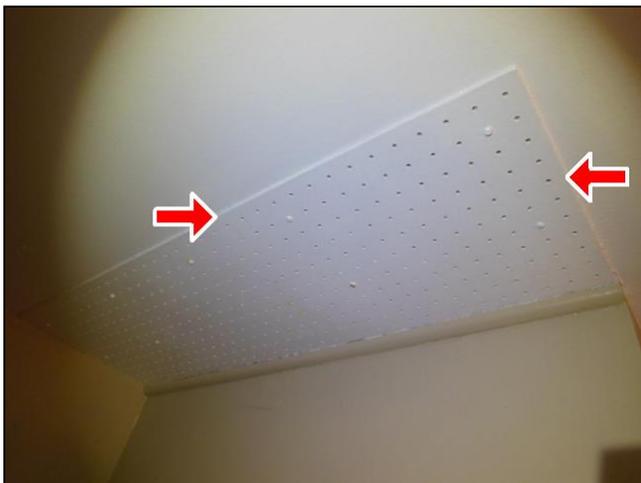
7.6 Item 1(Picture)

several Main building ceilings have poor or unusual patching of drywall over bathtub at shower head. They have been using "punch board" over top the drywall. Overall poor maintenance practice. Issue is exacerbated by the fact that all the bath exhaust fans operate independently (therefore they are often not used).

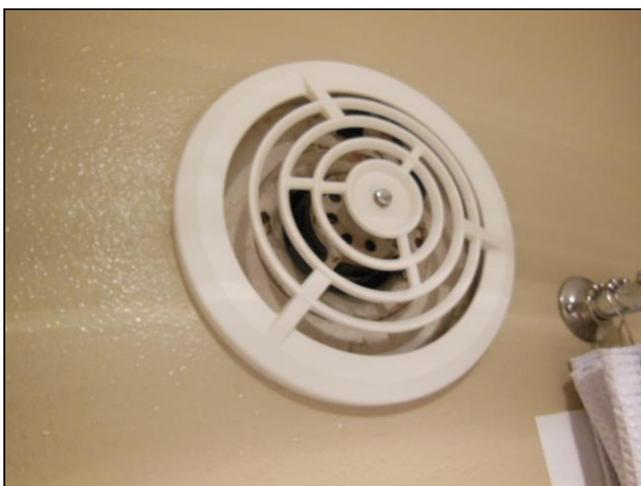
7.7 Item 1(Picture)

Main building bath fans have independent operation. Recommend all bath fans be slaved to light switch or on timers to insure operation and reduce moisture damage in rooms.

S Annex rooms have old side wall mounted bath fans that operate independently and have a low CFM rating. Recommend replacement and "slave" bath fan use.

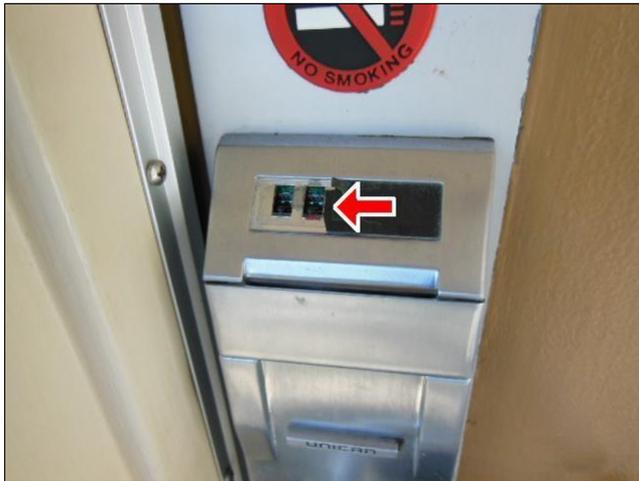
7.13 Item 1(Picture)

- (2) The magnetic card door lock system in the facility is quite old, some locks are damaged. These older card lock systems are only marginally supported and are being phased out throughout the hotel/motel industry as no longer cost effective to reliably maintain. It is unlikely that it will be feasible to maintain this system for another 5 years. We recommend you budget for replacement.

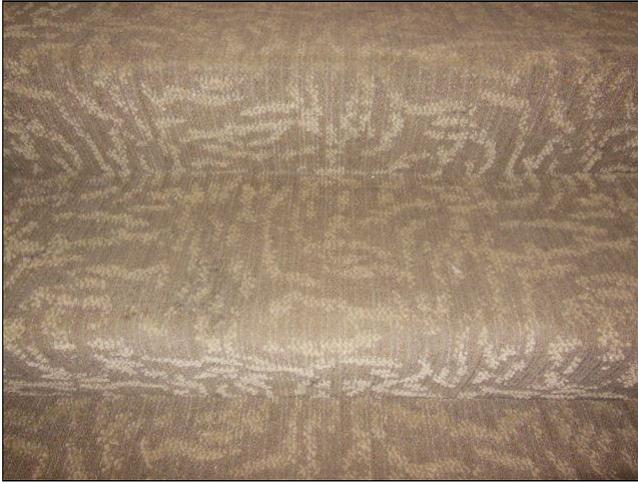
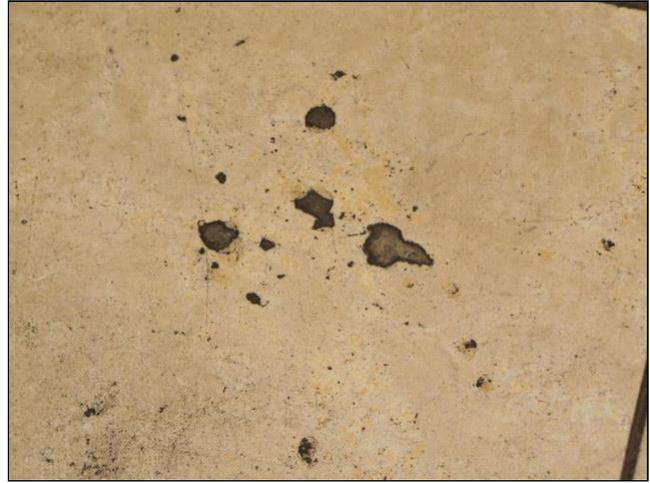
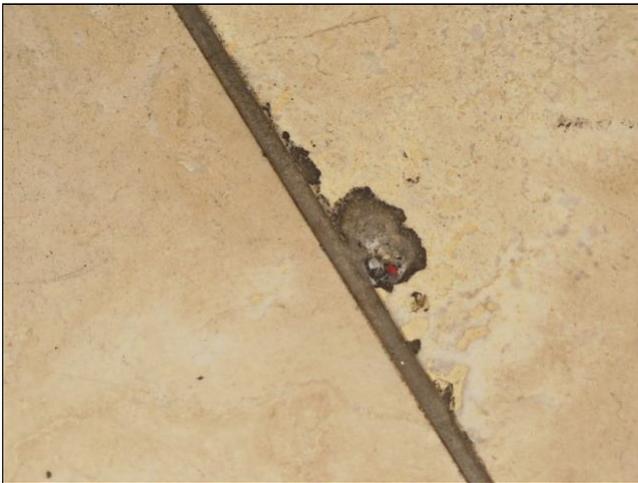
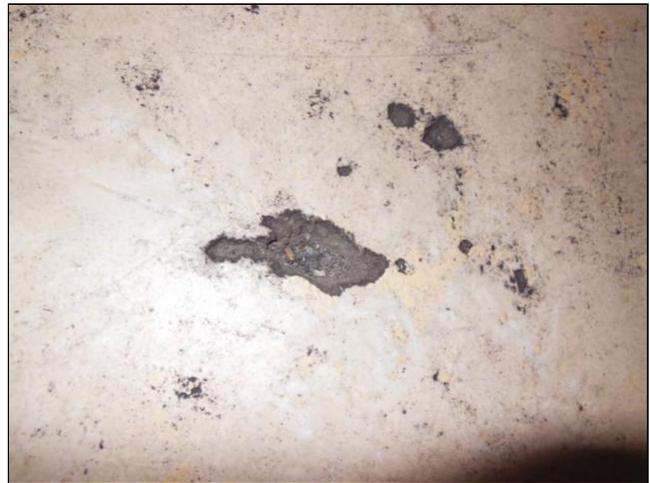
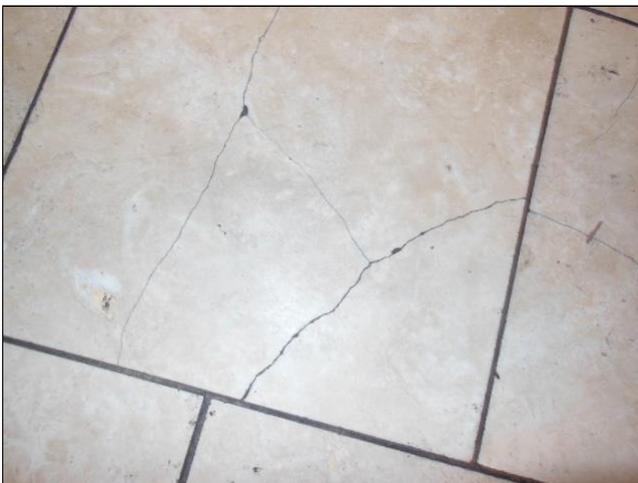
10.0 Common areas

(1) Main Entry Lobby, several tiles damaged. Interior stairwells, carpet worn, loose.

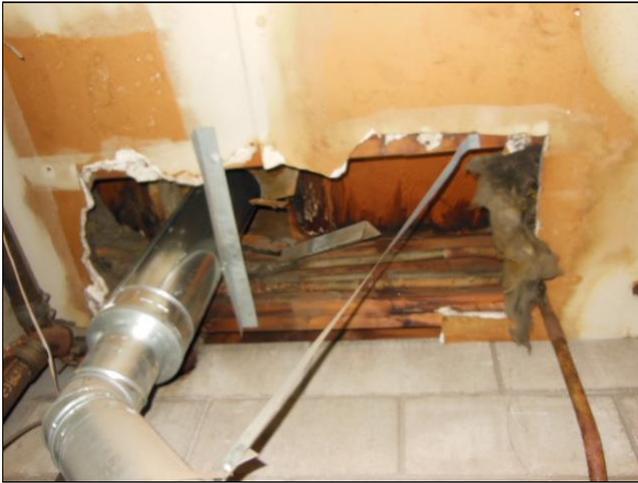
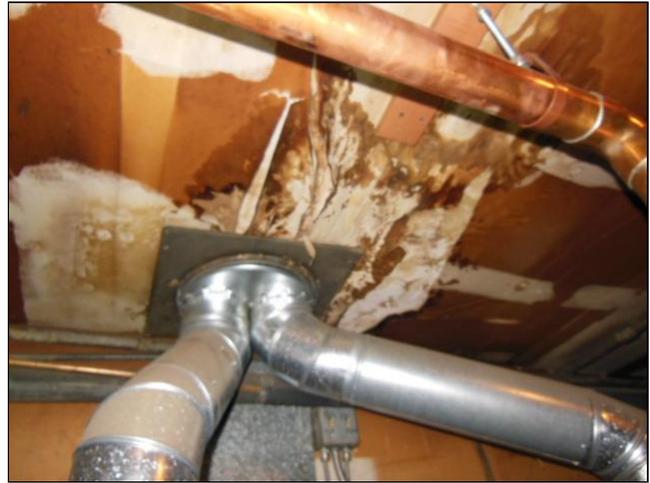
(2) pool equipment area ceiling moisture damage. tested dry at time of inspection. Moisture damage over main building water heater installation, also tested dry at time of inspection. Damage may predate exiting roof cover.

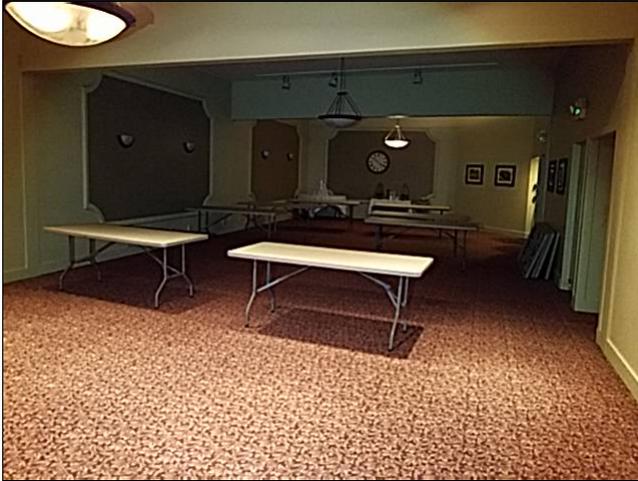
12.2 Item 1(Picture)

Large conference room or classroom in acceptable condition.

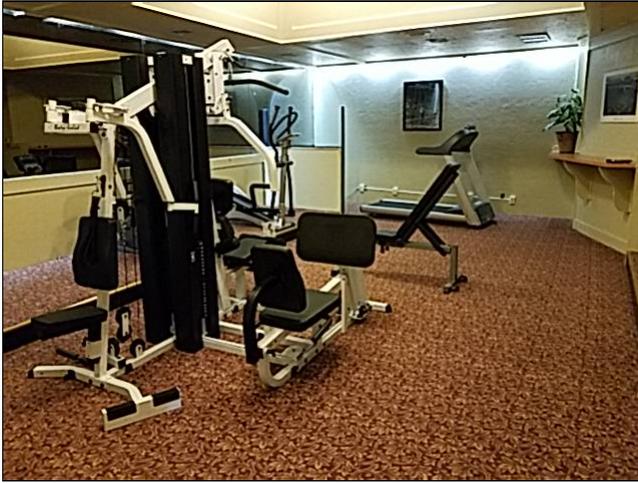
13.0 Item 1(Picture)

Fitness area was formerly a lounge/bar .
