Attic pull down ladders

Tales from the Crawlspace
By Propertyexam

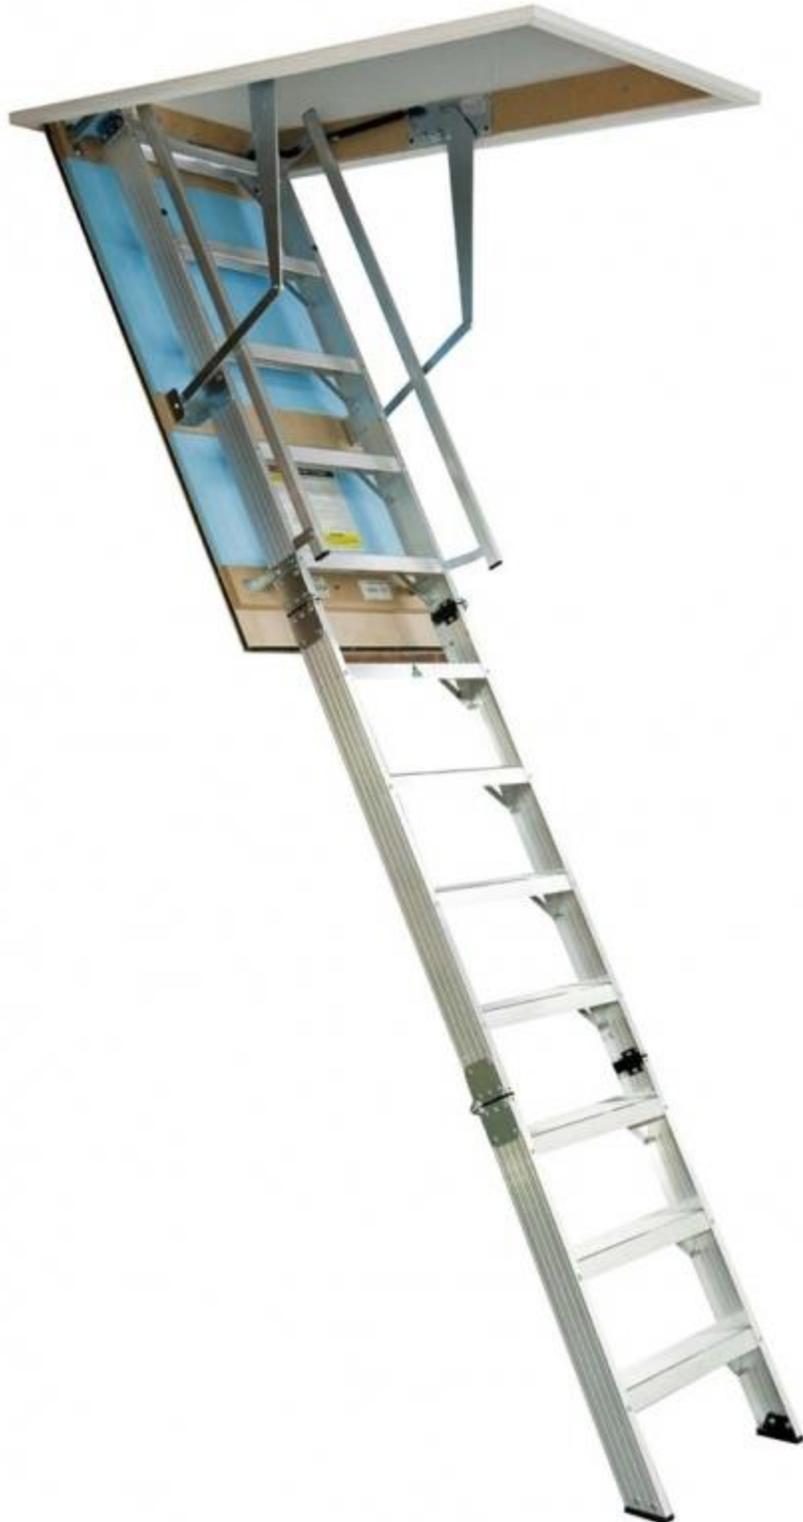
- cut bottom cord of structural truss. Often, homeowners will cut through a structural member in the field while installing a pull-down ladder, unknowingly weakening the structure. Structural members should not be modified in the field without an engineer's approval;
- fastened with improper nails or screws. Homeowners often use drywall or deck screws rather than the standard 16d penny nails or ¼" x 3" lag screws. Nails and screws that are intended for other purposes may have reduced shear
