## Go Green with Thermal Imaging

Peter Hopkins  
SoCal Infrared ([www.socalinfrared.com](http://www.socalinfrared.com))

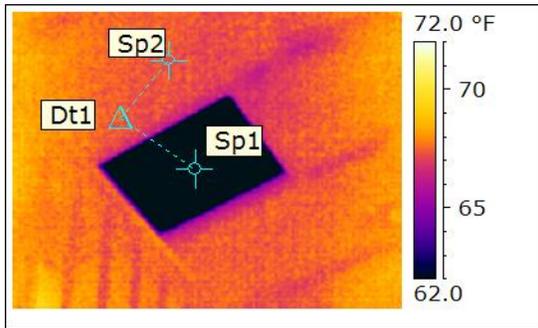
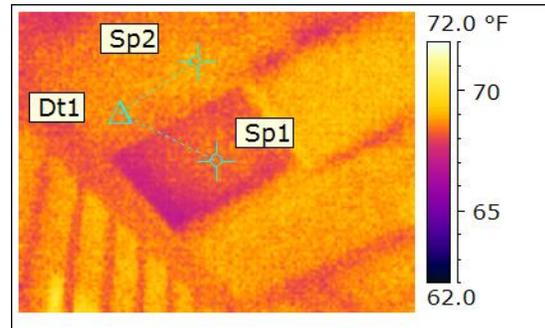
*Figure 4a. No Insulation  
Image.Date 2/20/2006 Image.Time 10:00:17 AM  
Temperature difference: Dt1 -6.4*

*Figure 4b. Same image taken 45 minutes later  
Image.Date 2/20/2006 Image.Time 10:47:37 AM  
Temperature difference Dt1 -0.6*

In the image above, you can see how easy it is to tell when you have no insulation on the attic access cover (a great opportunity for heat to escape). In reality, you can see this without an infrared camera by simply going into the attic but if you're like many of my clients, they have never removed the access door or entered the attic. This is a very common area where insulation is missing. We have visually identified this condition on thousands of homes that we have inspected over the years. The image to top right confirms the benefit of insulation after repair in only forty five minutes time. Notice the temperature delta's between both images.

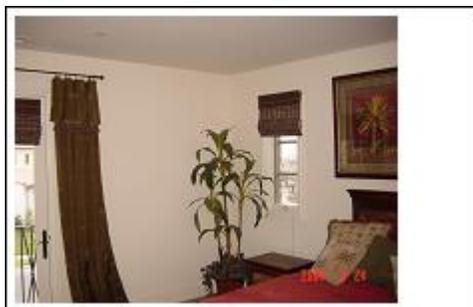
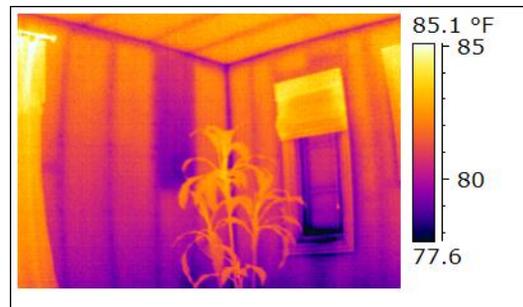
*Figure 5a. Visually you cannot see missing insulation*

*Figure 5b. Thermally it is very easy to identify*

“You Can't Correct what You Don't Detect”! Outside of destructive testing, infrared is one of the most effective methods of identifying missing or inappropriately installed insulation in a home or business. An infrared camera brings to light the affected area which allows you to carry out repairs in an effective manner.

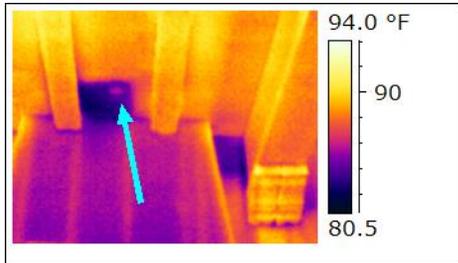
Recessed lighting installed in homes today are “IC/AT” Insulation Contact Air Tight style but as you see in image below, some of the contractors are installing lights to previous style which required a 3” gap due to

overheating. These older types of can lights were like having big holes in the ceiling for all your conditioned air to escape. The can lights needed the gap as the fixtures would get just too hot and would possibly ignite due to overheating. As you can see in the image below, they left a pretty good air space that was not needed as this was a new home and the light fixtures were the IC/AT type.

Figure 6. Thermal image showing gaps around can light

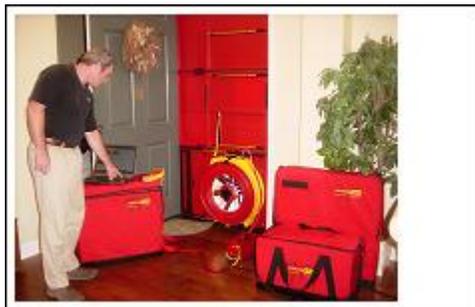
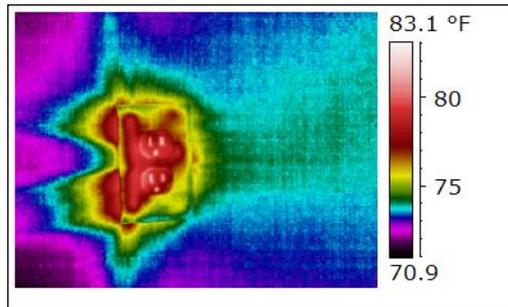
Figure 7a. Door-Fan Testing

Figure 7b. Electrical Outlet Leak

The image to above right shows an electrical outlet during a Door-Fan test. Installing a rubber gasket behind the plate or caulking can help reduce conditioned air loss.

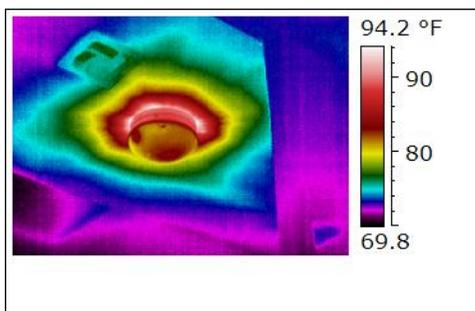
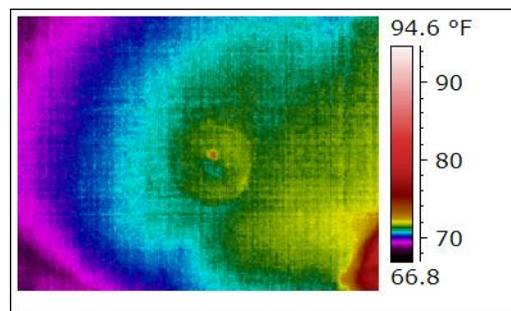
Figure 8a. A light fixture not caulked/sealed at ceiling

Figure 8b. A light fixture 5 feet away that is sealed properly

The above pictures were taken about 5 feet from each other and were the same style light fixture in a brand new home. As you can see when they leak, it shows up beautifully on the infrared camera and when they don't, they blend in with adjacent area as the image on above right. The image to right is actually the prettier picture when you are trying to save energy.

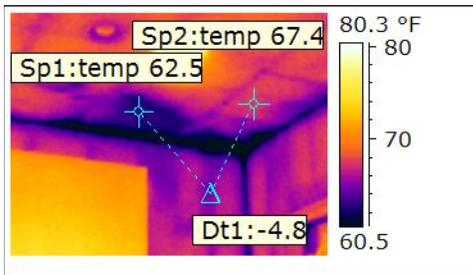
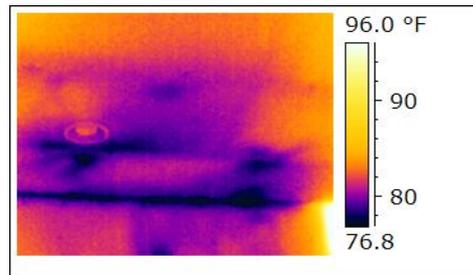
We have found that loose fill insulation (fiberglass, cellulose etc.) appears to work quite well in attics or tight places as the small areas especially around can lights will get filled more evenly rather than trying to cut batt style insulation to conform around these areas. It is easily seen thermally when they do not install the

insulation evenly or gaps are present as the patterns will vary, unlike batt insulation which typically will appear as squares when it is missing.

Figure 9a. Loose uneven insulation

Figure 9b. Uneven blown in insulation

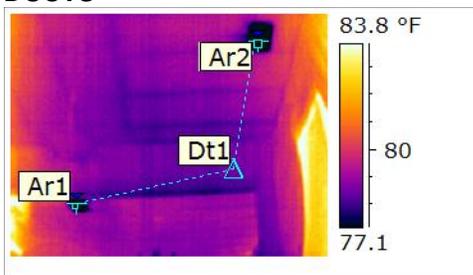
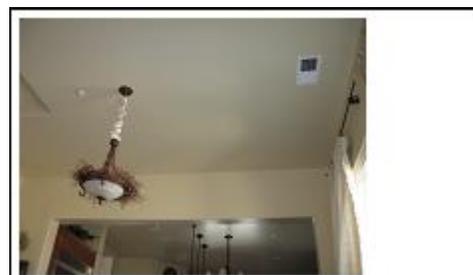
Figure 11a. Ar1.Min Temperature 56.8 °F  
Ar2.Min Temperature 68.3 °F  
Temperature Difference: Dt1 -4.8

Figure 11b. Visual image

In the example above, the complaint that the family room of this home was not getting cool enough. A simple analysis with infrared identified an 11 degree difference between ducts that are only about 15 feet from each other and are running on the same system. Further analysis identified that the warmer area had a single line duct split to three locations versus the other area had a dedicated line. By simply increasing duct size over

family room or dedicating more air flow, the area will be made more comfortable. Testing temperatures with infrared at each heat register and recording differences can often help explain why some rooms might be cold and some may be hot.

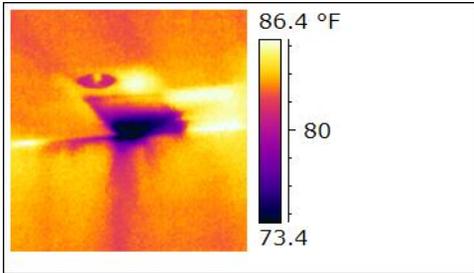
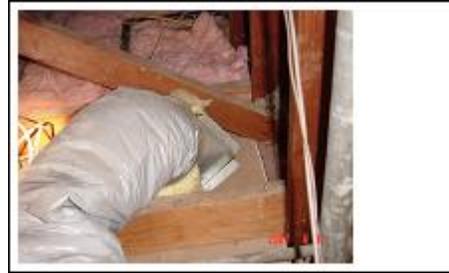
Figure 12a. Thermal showing cold spot at ceiling

Figure 12b. Attic photo showing duct not installed and blowing air into attic

An infrared survey in this home (above image) identified a cold area in a ceiling, it was later found out that the contractor had sealed over or never accommodated for installing the heat register in ceiling. The duct was discharging directly into attic.

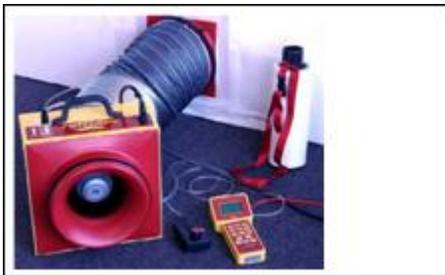
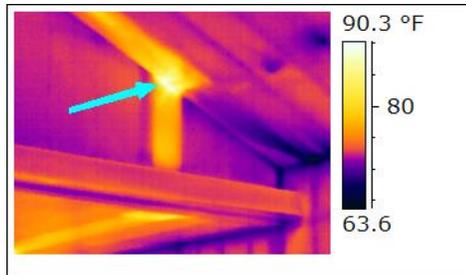
Heating and Cooling equate to about 45% of average utility consumption and many of the existing homes have leaky ducts averaging in the 25-30% range, this can equate to a significant energy loss. The method used to identify measured air leakage rate of ducts is through the use of a duct tester although identifying the locations of the leaks might be another process in itself. Often they induce a fog into the duct fan during the test but sometimes there are locations that you simply cannot get too and as you see in image below right, an infrared camera can be very useful in this situation.

Figure 13a. Duct testing equipment:  
Image courtesy of Retrotec

Figure 13b. Leaky joint in duct (inaccessible location)

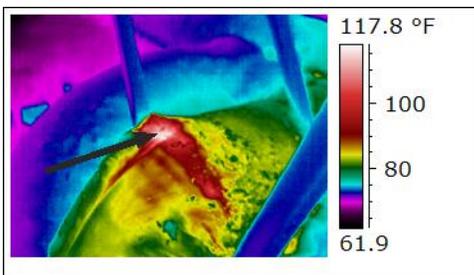
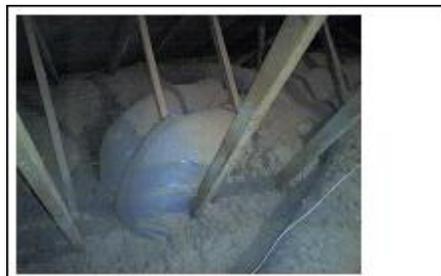
Figure 14a. Thermal image showing duct leak

Figure 14b. Visual image of duct

Thermal imaging can save a lot of time as the results are immediate. By seeing the anomaly, you know where to focus your repair efforts.

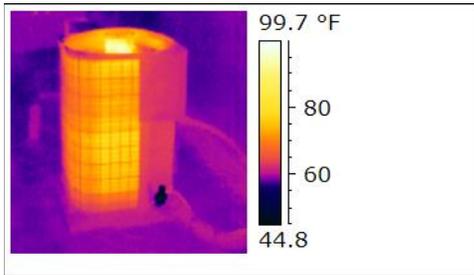
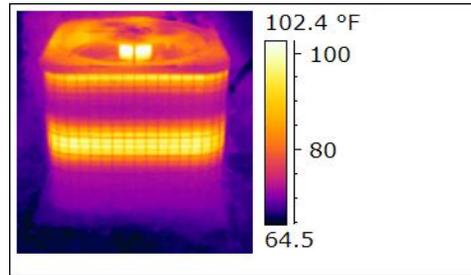
Figure 15a. A properly operating system with even displacement of heat

Figure 15b. An obvious restriction

The image to top right has an obvious restriction and if left to further operation can result in a damaged unit. This client had complained that it just was not getting cool enough. I think we have identified the problem.

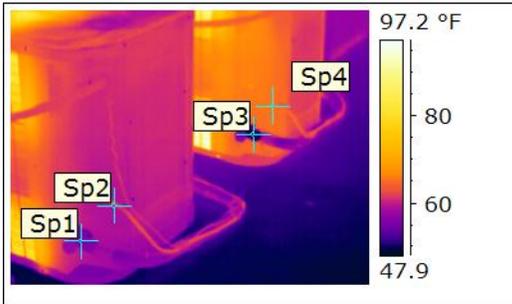
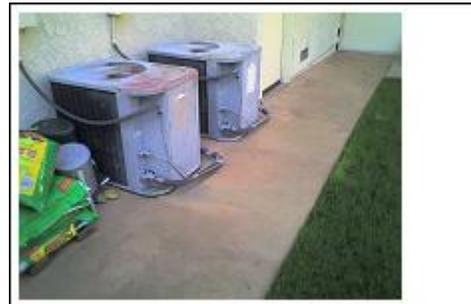
Figure 16a.  
Sp1. Temperature 56.3 °F Sp2. Temperature 59.9 °F  
Sp3. Temperature 49.6 °F Sp4. Temperature 65.0 °F

Figure 16b. Visual

The above air conditioning units were equally sized and running for the same amount of time. With an infrared camera by simply measuring temperatures of liquid and gas lines, you can help identify how much cooling is taking place. Often a 14-22 temperature delta t is desired, anything less or more in some cases can indicate improper operation. In the thermal image above you can see the forward unit only has a temperature difference of 3.6 degrees whereas the rear unit has a difference of 15.4 degrees. In this case, the client was complaining that the downstairs had inadequate cooling. Infrared quickly confirmed their suspicion. A proper charge on your air conditioning unit will give you the biggest return on your utility dollar investment!

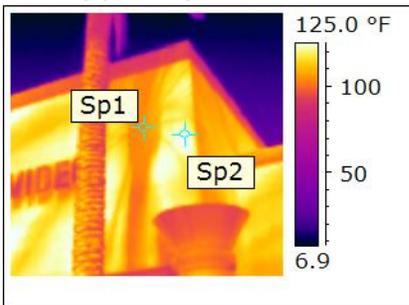
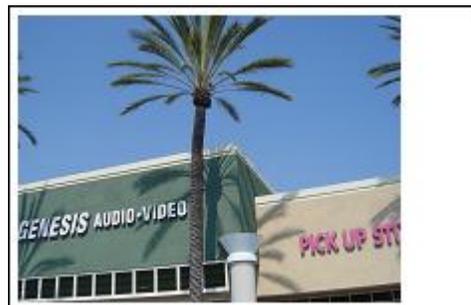
Figure 17a. Thermal picture of tree shading home  
Sp1. Temperature 104.0 °F  
Sp2. Temperature 124.4 °F

Figure 17b. Visual Picture

You can't argue that proper landscaping will benefit your comfort in the home. Strategic placement of trees can add an aesthetic value to your home but also savings to your heating and cooling consumption. It is stated that carefully positioned trees can save up to 25% of the energy a typical household uses for cooling. As evidenced in image above, you can see the temperature difference the shade makes on a home. Now obviously a palm tree is not the ideal tree when you desire a shade tree but for our example, it shows an easy comparison. There is over a 20 degree difference between shaded and sun exposed stucco.

Utilizing renewable energy is just plain smart. Take a look at the image shown earlier in this paper of the tree shading the building. The unshaded temperature of the stucco was 124 degrees just going to waste. Consider if you were to have solar harvesting on your roof be it water heating or solar electric panels. The sun's energy is free; why not take advantage of it and "Go Green".

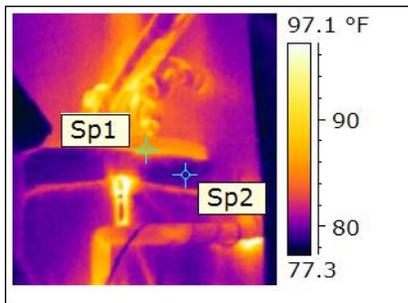
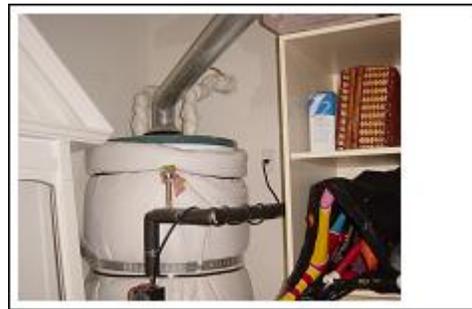
Water heating accounts for approximately 13% of your utility bill. I think we would all love to save where we can. As evidenced by images below, you can see how adding a blanket on your water heater can save you money.

*Figure 18a.*  
*Temperature readings at tank and insulated area*  
*Sp1. Temperature 86.6 °F*  
*Sp2. Temperature 79.5 °F*

*Figure 18b.*  
*Visual picture showing insulation pulled down at top*  
*which shows tank temperature vs. insulated temp.*

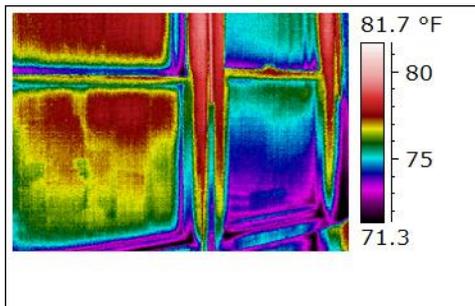
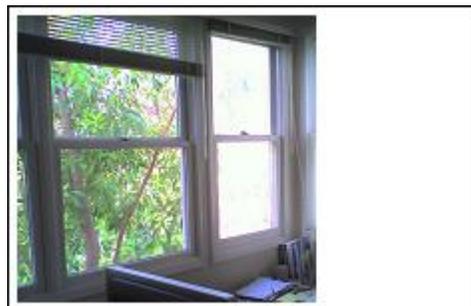
Can you tell which window is single pane? (Cold day, heater was on)

*Figure 19a.*  
*One window is keeping heat in,*  
*other letting heat out!*

*Figure 19b.*  
*Visual image*

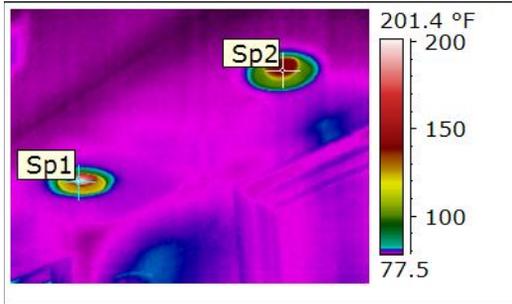
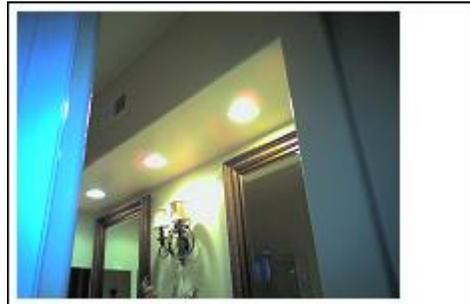
*Figure 20a.*  
*Thermal view of both incandescent and fluorescent*  
*Sp1.Temperature 195.0 °F (incandescent)*  
*Sp2.Temperature 139.9 °F (fluorescent)*

*Figure 20b.*  
*Fluorescent on right, incandescent in middle*

As you can see in thermal image, there is over a 55 degree difference between the incandescent and fluorescent light bulbs and when looked at in visual image, they appear to produce the similar lighting but obviously a big difference in the heat they produce. As a point of thought, during summer, the heat generated from these 195 degree bulbs will add to your utility load as your air conditioning unit will have to compensate for all this extra heat. Switching to fluorescent in addition to reducing your compensated cooling, will save you over 75% of your consumed wattage...a definite "Going Green".

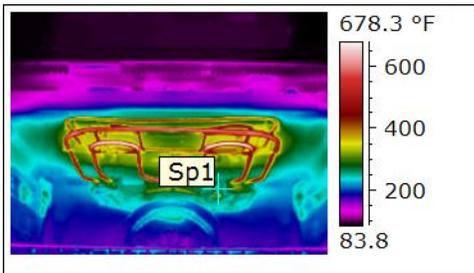
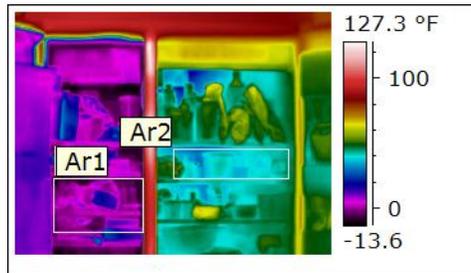
*Figure 21a. Oven Element*  
*Sp1.Temperature 232.0 °F*

*Figure 21b. Freezer/Refrigerator*  
*Ar1.Average Temperature \*2.4 °F*  
*Ar2.Average Temperature 38.9 °F*

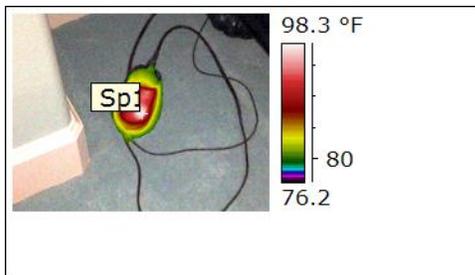
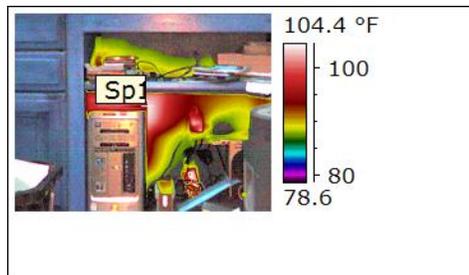
*Figure 22a. Small electronic power supplies left on unnecessarily  
Sp1.Temperature 97.6 °F*

*Figure 22b. Computers left on when not in use. See the heat  
Sp1.Temperature 101.8 °F*

I decided to take this one step further and take a wattage reading on my computer alone. I found not only via thermal imaging that these equipment pieces were generating a lot of heat, but my computer alone was costing me 4 cents an hour to be on....This may not seem like a lot but you do the math, it comes close to \$30 a month of my electric bill.
