Using Infrared for Residential Energy Surveys

Dave McCullen
Sumter Electric Cooperative Inc.

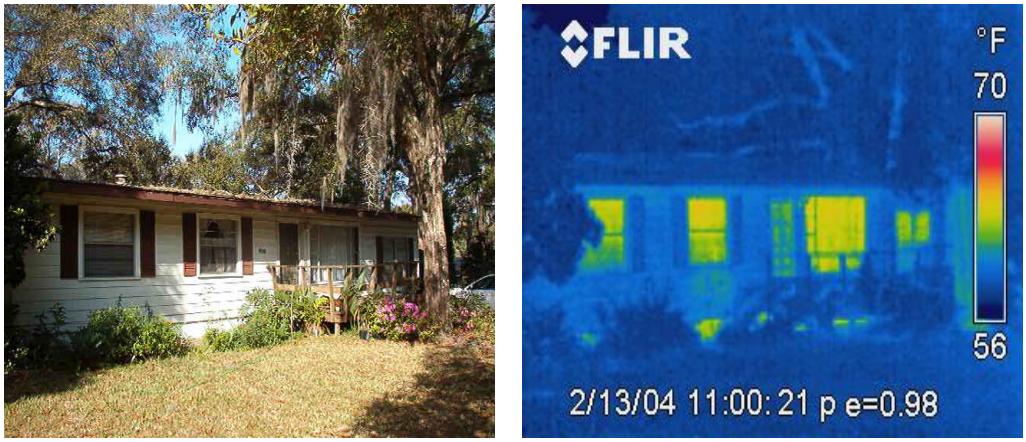
Figure 1. Areas of winter heat loss in a single-story existing dwelling

New home construction and insulation requirements have improved greatly over the last few years. Most states either have or are working on energy rating programs that conform with the Federal Environmental Energy Efficiency guidelines; however, most existing homes and quite a few of the new ones built today have areas that could be greatly improved. In Figure 1, this home looks cozy enough in this winter setting, but infrared shows areas of significant heat loss through the windows, doors, and even under the floor level in the crawl space. Ceiling insulation here appears adequate, but floor insulation is lacking.

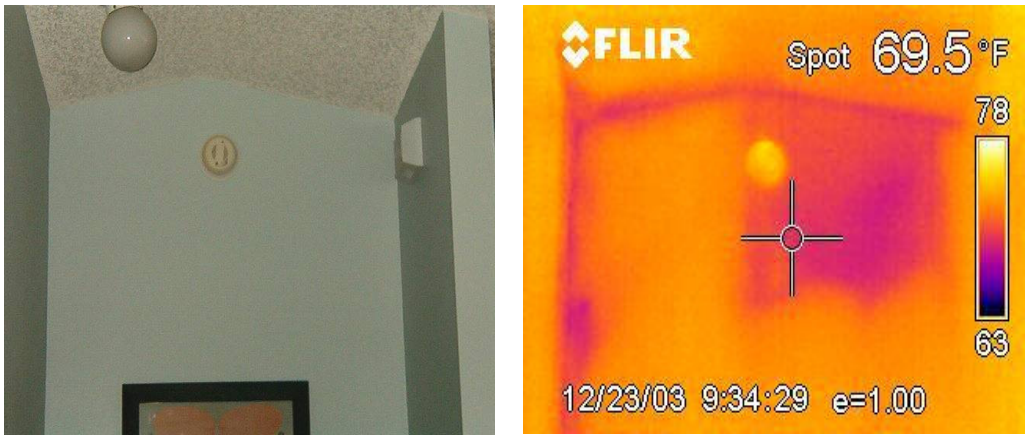
Figure 2. Areas of heat loss through a standing wall that is not insulated

Standing walls in a home that are not adequately insulated can be significant areas of heat loss or gain, especially when large temperature differentials occur on each side. Figure 2 shows large gaps in the standing wall insulation between different ceiling heights. Attic inspection revealed that the insulation had been pulled away from the wallboard, allowing cold attic air to get behind the insulation and cause heat loss into the attic. The problem was evident in several areas of the same home.

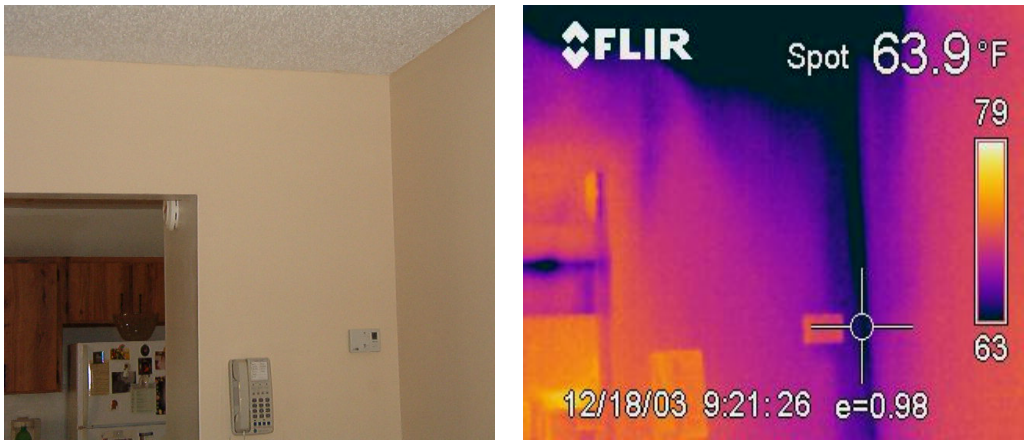
Figure 5. Cold air being drafted in a hollow wall behind the thermostat

Without the use of an infrared thermal imaging camera, one of the hardest problems to find in a home is the existence of thermal ducting inside the wall structure affecting the regulation of the system. This phenomenon affects the HVAC running time by infiltration of humidity and heated air into the conditioned space. It can also affect the thermostat by heating or cooling the wall behind it, thereby greatly extending the time the thermostat calls for conditioning. Figure 4 illustrates this phenomenon very clearly. The return was cut through a hollow wall, and the passage was not sealed from the wall cavity. When the unit was running, the resulting low pressure inside the return passage lowered the pressure inside the wall, and hot attic air moved in to replace it. The thermostat visible on the wall was set at 80°F, but the wall temperature just under it was 87°F. This caused the unit to keep running almost constantly. Without the thermograph, this problem would be difficult, if not impossible, to find. Figure 5 shows the same ducting situation in another home during the winter heating season. Notice the cooling of the wall behind the thermostat.

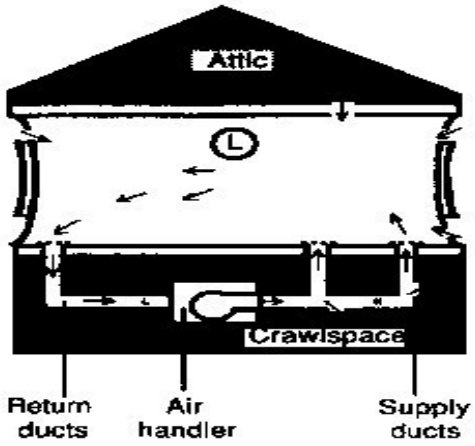
HVAC system supply leaks are one of the most significant problems causing higher energy usage in today's homes. The leaks in a ductwork system outside the conditioned space allow air to be lost to the outside and will depressurize the entire home, as in Figure 6. This will pull in outside air from all the infiltration routes in the home previously mentioned. This adulteration of the conditioned space can be significant enough to greatly extend the running time of the unit, since most of the make-up air is usually brought in from the attic.

Figure 6. House depressurization due to supply duct leaks [1]

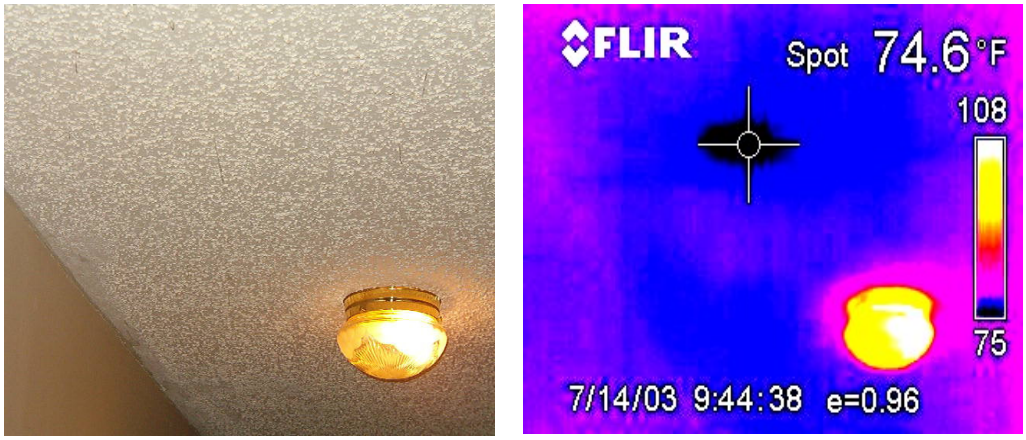
Figure 7. Cold spot on hall ceiling caused by supply junction leak in attic over ceiling board

Figure 7 shows a cold spot on the hallway ceiling that indicated a possible leak in the supply system in the attic of this home. Attic inspection showed exactly that, as seen in Figure 8. In fact, the entire supply ductwork system in this home was leaking significantly at every junction, as well as the connection with the ceiling supply inlets, losing conditioned air into the attic. The thermograph, showing a cold spot where none should be, led to a significant find that otherwise could easily have been missed.

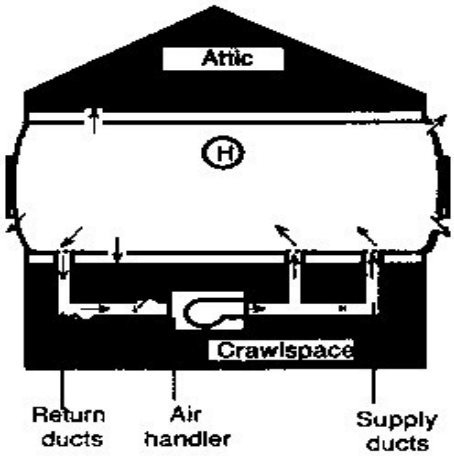
Return leaks also significantly increase the pressure inside the house by drawing in air from outside the system as shown in Figure 11. This excess air is drawn in and compressed by the large blower in the air handler. This causes the increased pressure of the conditioned air inside the home to seek equalization by escaping through the normal infiltration routes to the outside.

Figure 11. Home pressurization due to return duct leaks [2]
