## PROPERTY CONDITION REPORT

1006 SE Grand Ave., Portland, OR,

9/22/2008 at 6:41 PM

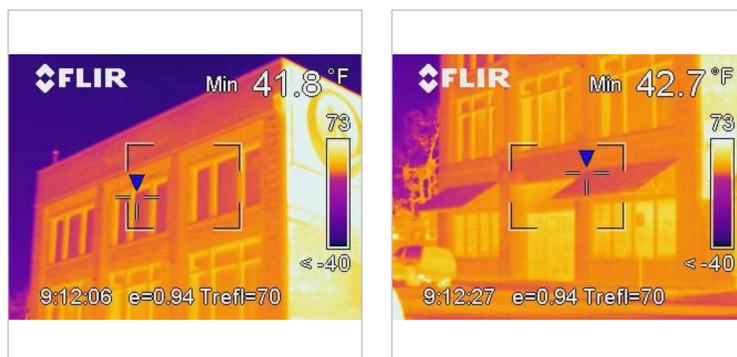
A thorough Thermal Imaging moisture scan was conducted and analyzed of the structure. All exterior walls, soffets and trim areas were scanned from the exterior and interior. The entire roof envelope was scanned from the attic interior and the crawlspace area was also scanned and analyzed. All suspect areas were also checked with an electronic, non destructive moisture meter. In all of the tested areas, there was no evidence of moisture intrusion found at the time of the inspection except where otherwise noted.

The scan was conducted with a FLIR High resolution E320 IR Camera, Calibrated 11/30/2007.
