Inspection Report

Property Address:

somewhere
sometown OR

Date: Invalid DateTime	Time:	Report ID: Hotel Sample 2
Property: somewhere sometown OR	Customer: someone	Real Estate Professional:

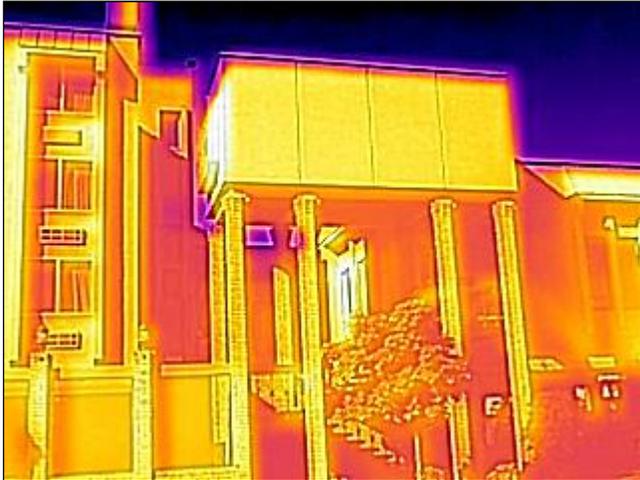
2.0.A Item 11(Picture)

(1) Overall the exterior cladding is in good condition . There is some weathering of the exposed wood trim on the exterior that needs touchup paint seal service now and repainting within 3-5 years. There are a few typical minor mechanical damage areas to the stucco.

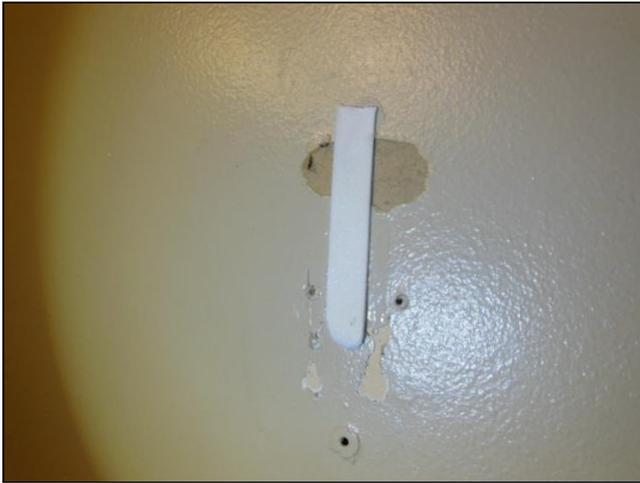
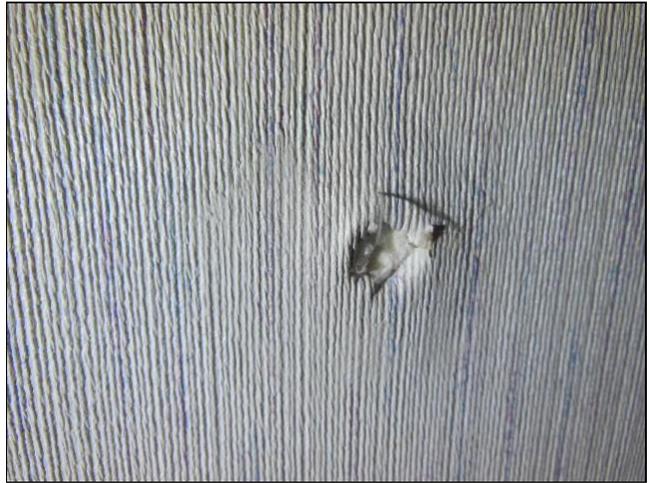
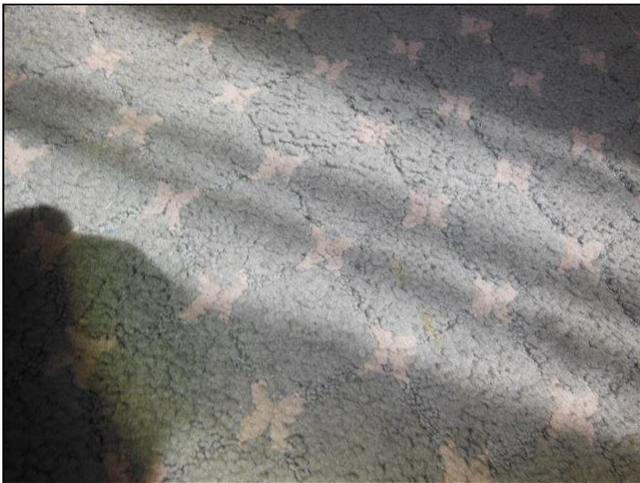
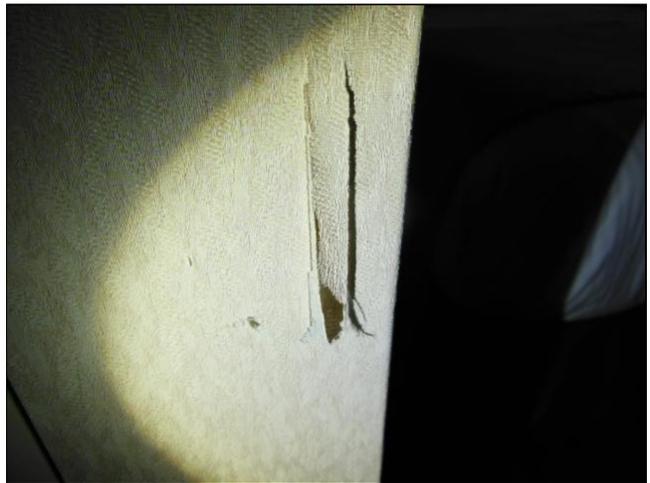
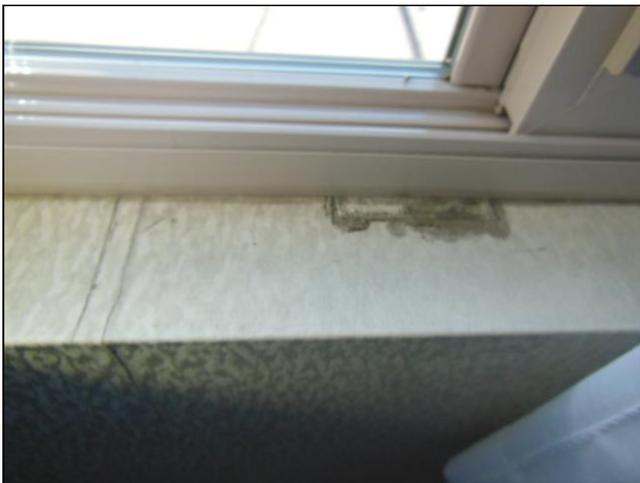
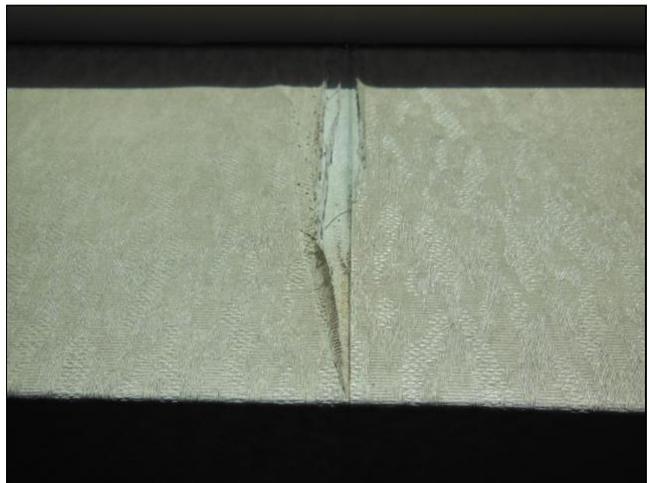
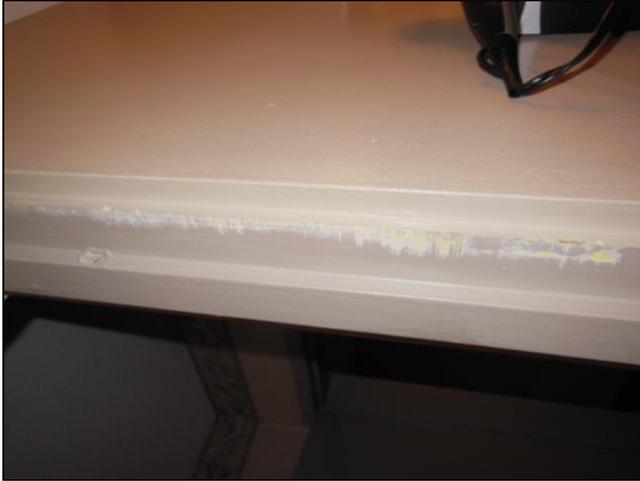
Wallpaper in Main building, textured drywall in S Annex. Typical wallpaper sloppy patching and peeling.

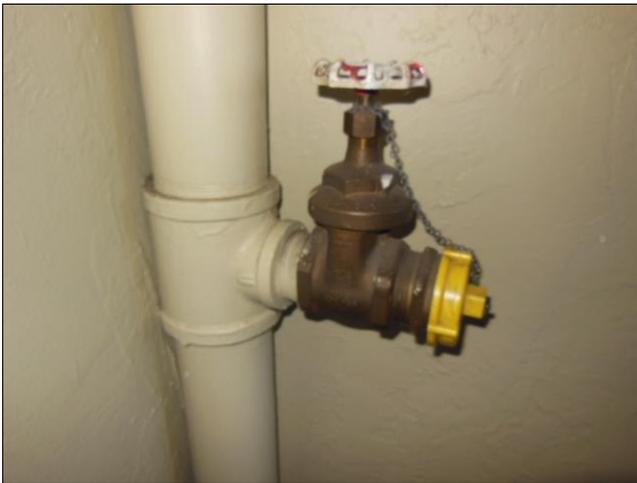
14.2 Item 1(Picture)

assent property and within main building no hoses or equipment.
